P11F REDISCOVERED

Michał Skawiński

History of the Type

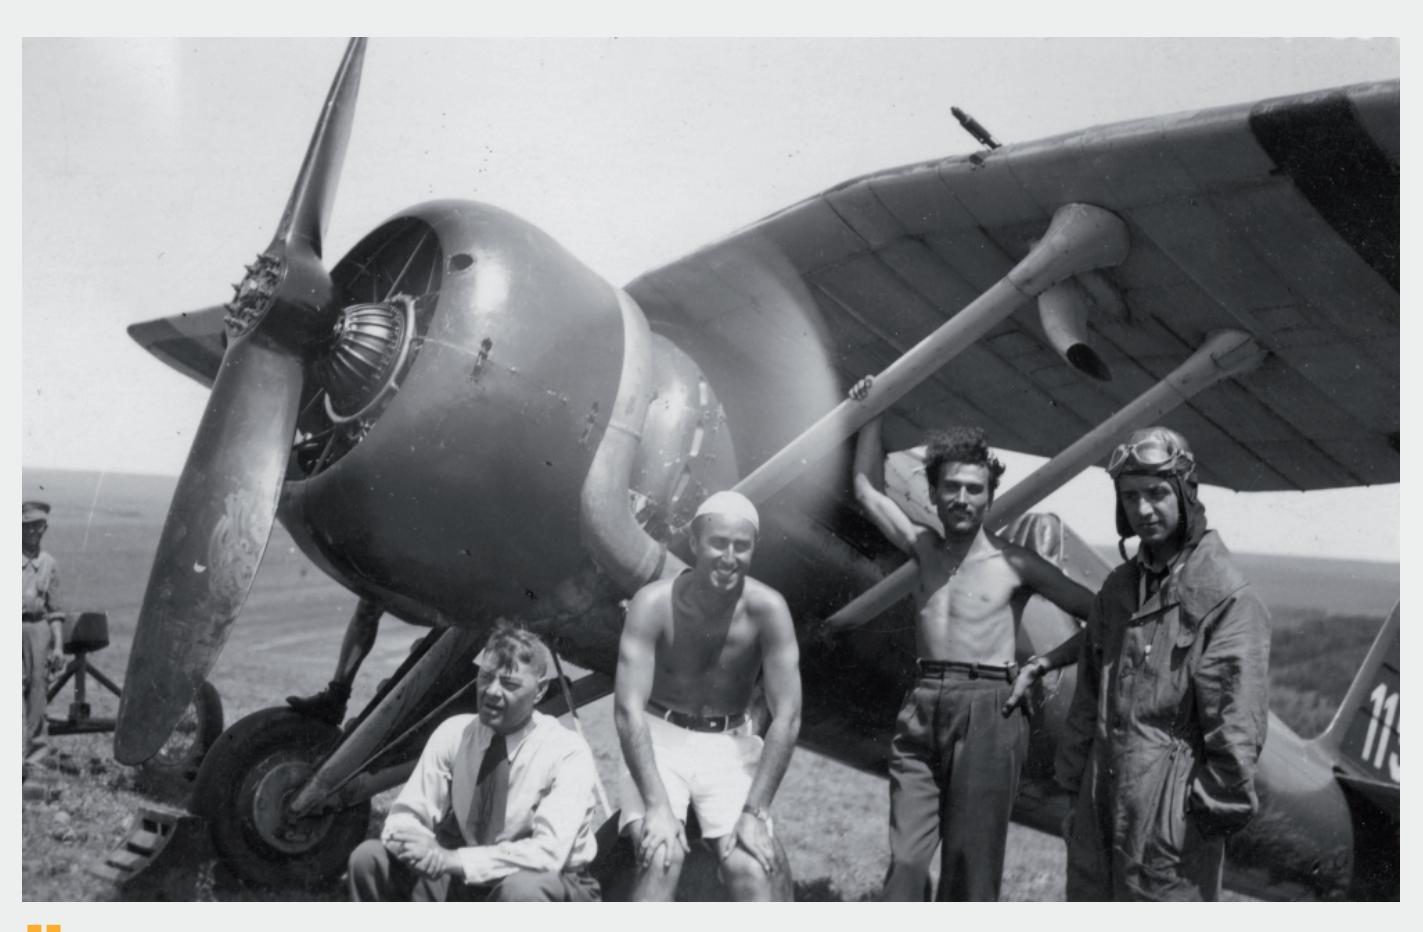
All the main features of the 'F' version in one photo! Note the engine and its covers, exhaust manifold, propeller without spinner and the FN Browning machine guns in the wings. In the background there is a trolley used for moving the airplane around the field - in order to do that it was necessary to lift the tail and put the trolley under the tailskid. (Horia Stoica/Dan Antoniu collection)

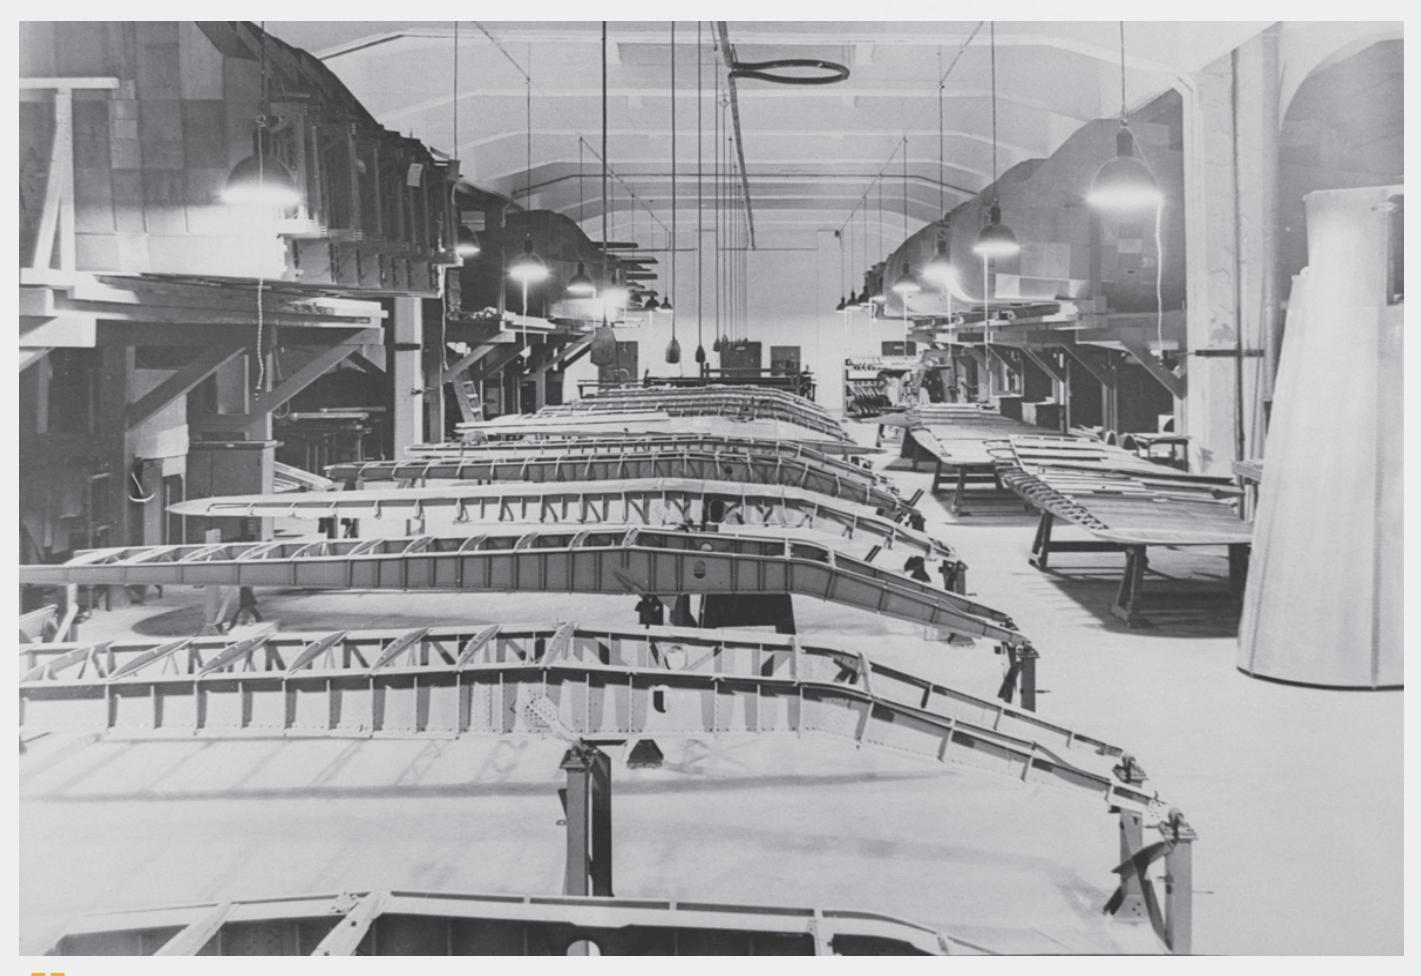
Inside of the hall where P.11F wings were produced (to the left in the aerial photo). Visible are both port and starboard wings in different stages of completion. Far in the back and slightly to the right there is a stand with wing spars ready for wing construction (taking place in the centre row). Completed wings are put on the stands above the main area of work. A bell-shaped structure to the right is in fact a semi-monocoque part of the P.11F fuselage. (Horia Stoica/Dan Antoniu collection)

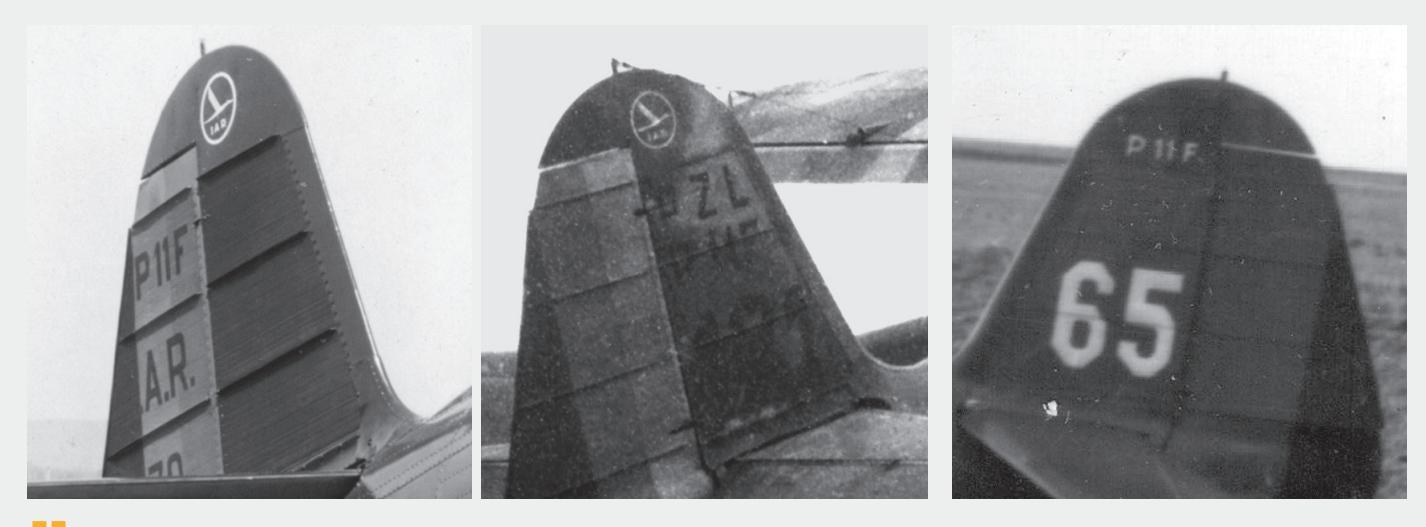
On the tails capital letter F was also used consistently. In the left photo there are visible original factory markings with both IAR name (with dots) and logo (without dots). Post-overhaul airplane in the centre has the IAR logo, but the PZL name was used – in that case it was rather meant to point out not the producer, but the airplane type (as P.11F was most often simply described as 'P.Z.L.' or 'P.Z.L. 11F' in Romania). Note the very aesthetically pleasing IAR logo. (Tomasz Kopański and Horia Stoica/Dan Antoniu collections)

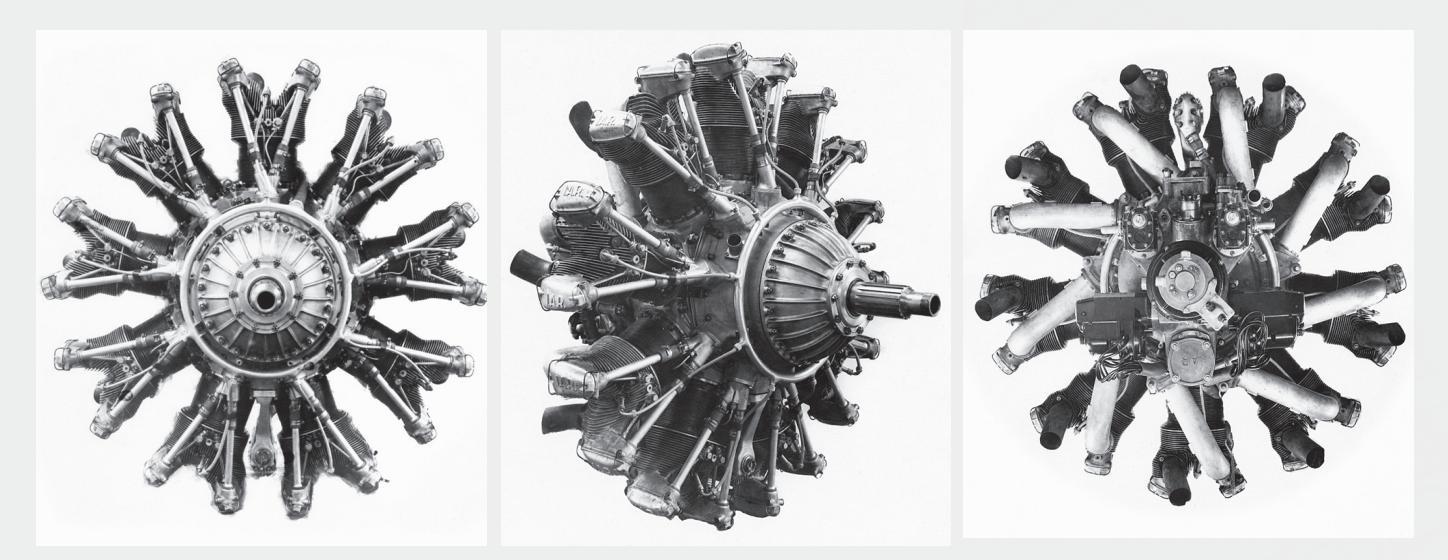
IAR 9K engine, license-produced Gnome-Rhône 9Krse engine. Rated at 600 HP it was a rough equivalent of Merkury V S2 powering the P.11c, giving P.11F similar performance. Note the wealth of details, with the 'I.A.R.' cast on the valve covers being well visible. (Horia Stoica/Dan Antoniu collection)

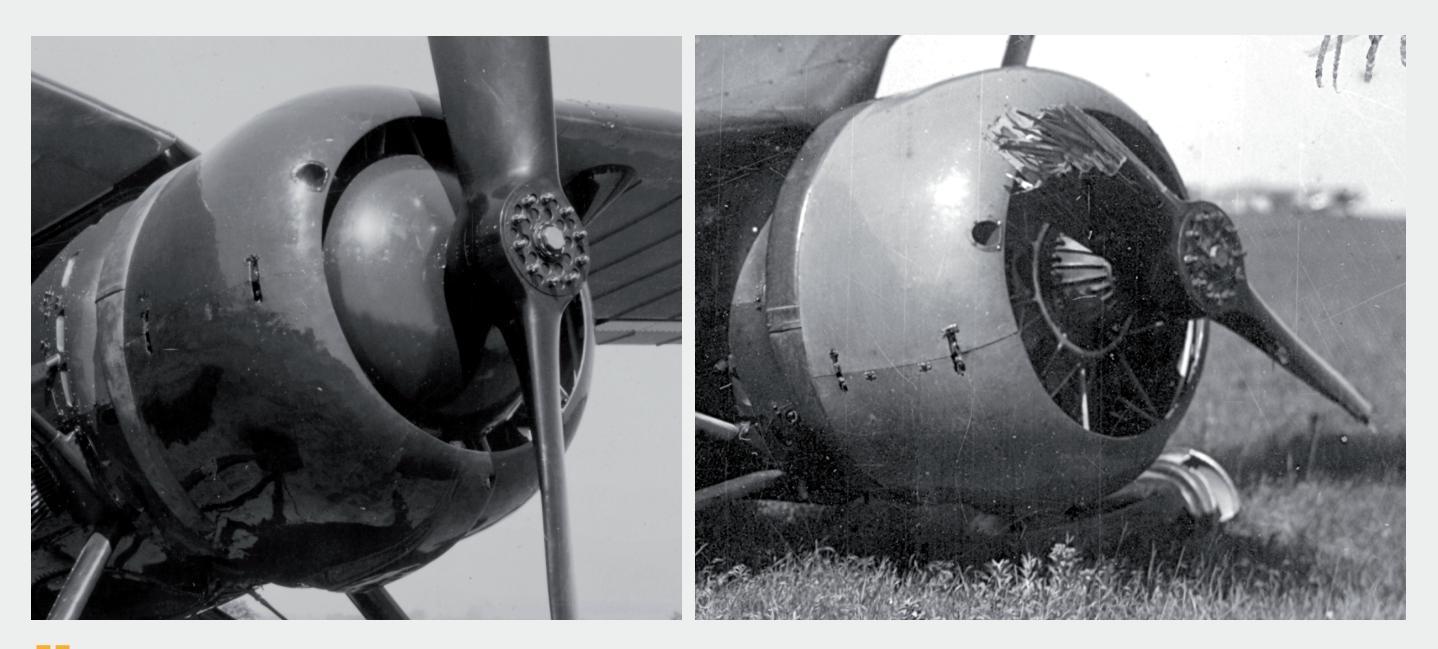
Engine cowling, one of the most aesthetically pleasing elements of the P.11F. Initially it included a front screen behind the propeller (photo at left), but it is hard to find them in the post-1939 photos. Most likely engine cooling was insufficient with them on and they were ordered to be removed. Right photo shows the cowling already without the screen. Note the fasteners and the gun throughs. Zoom in to see delicate, barely visible rivets. (Tomasz Kopański and Horia Stoica/Dan Antoniu collections)

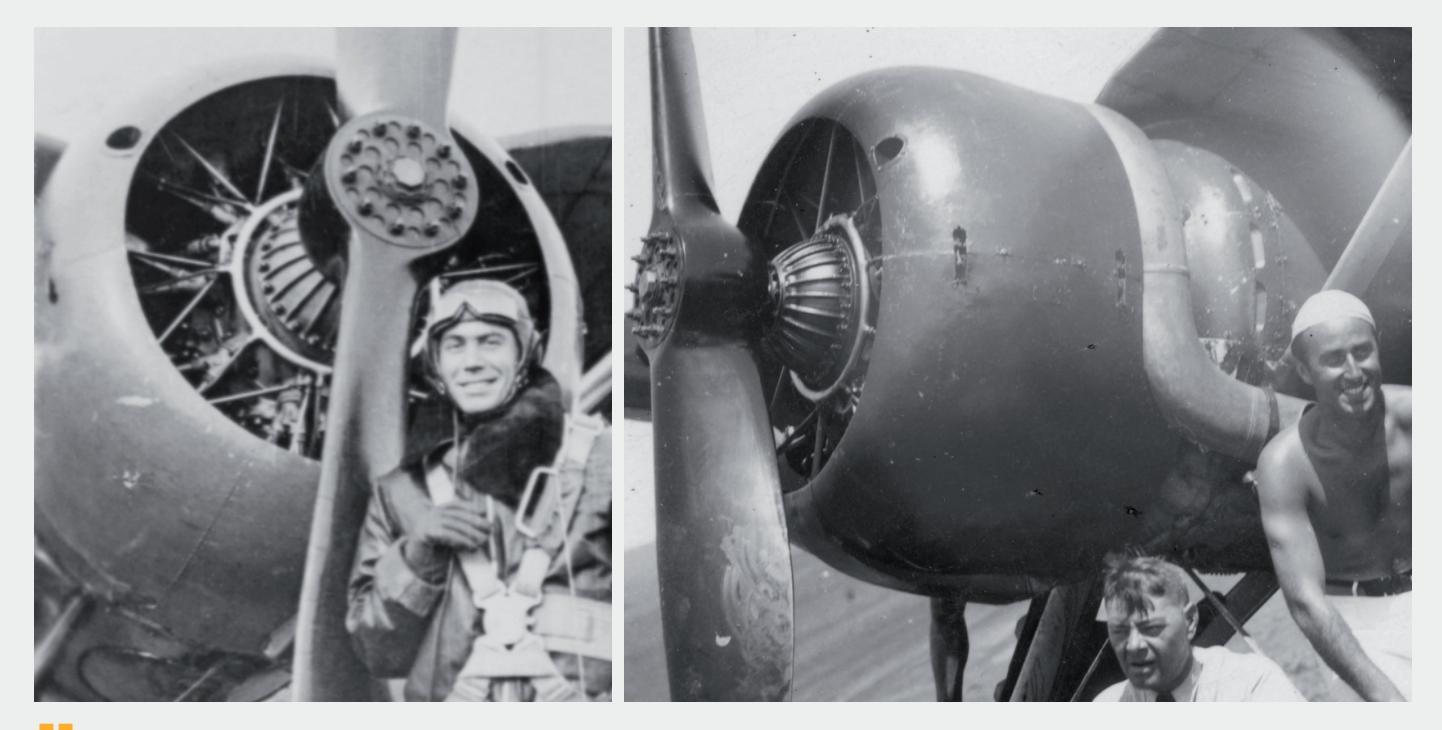
Two more photos of the cowled engine. Visible are additional details of the powerplant installation, panel lines on the cowling, fasteners on the port side and the exhaust manifold. Rectangular shape between fasteners (with 4 rivets) is an engine and cowling information plate overpainted in yellow, same as the entire cowling. (Horia Stoica/Dan Antoniu collection)

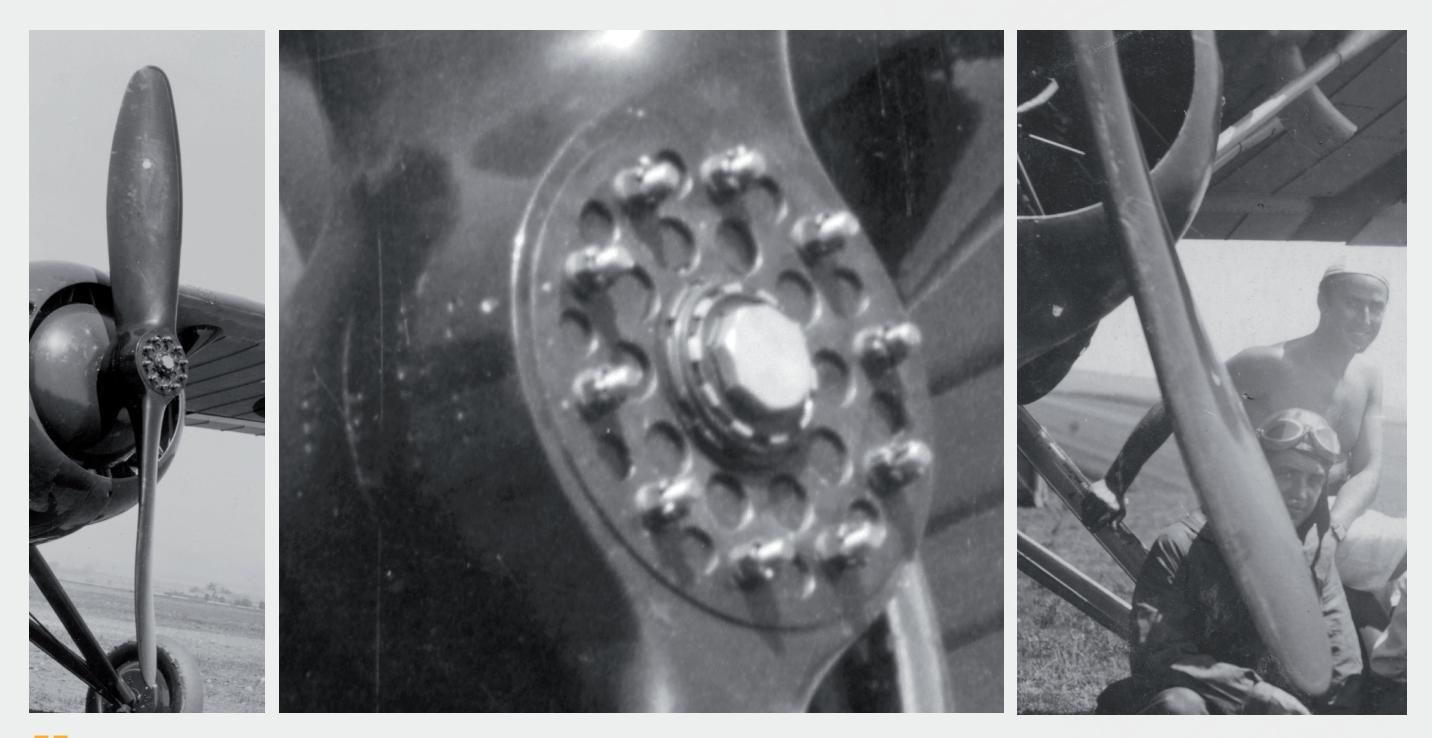
A propeller without spinner was a unique feature of the P.11F version. Note how the changing angle of attack causes the blade to look like it was bent forwards. Propeller hub has plenty of details and looks a bit Art Deco in its form, note the stamped lettering (unfortunately illegible) on its side. Right photo shows how the surface wore off as a result of usage – note the large number of scratches on the leading edge. (Tomasz Kopański and Michał Skawiński collections)

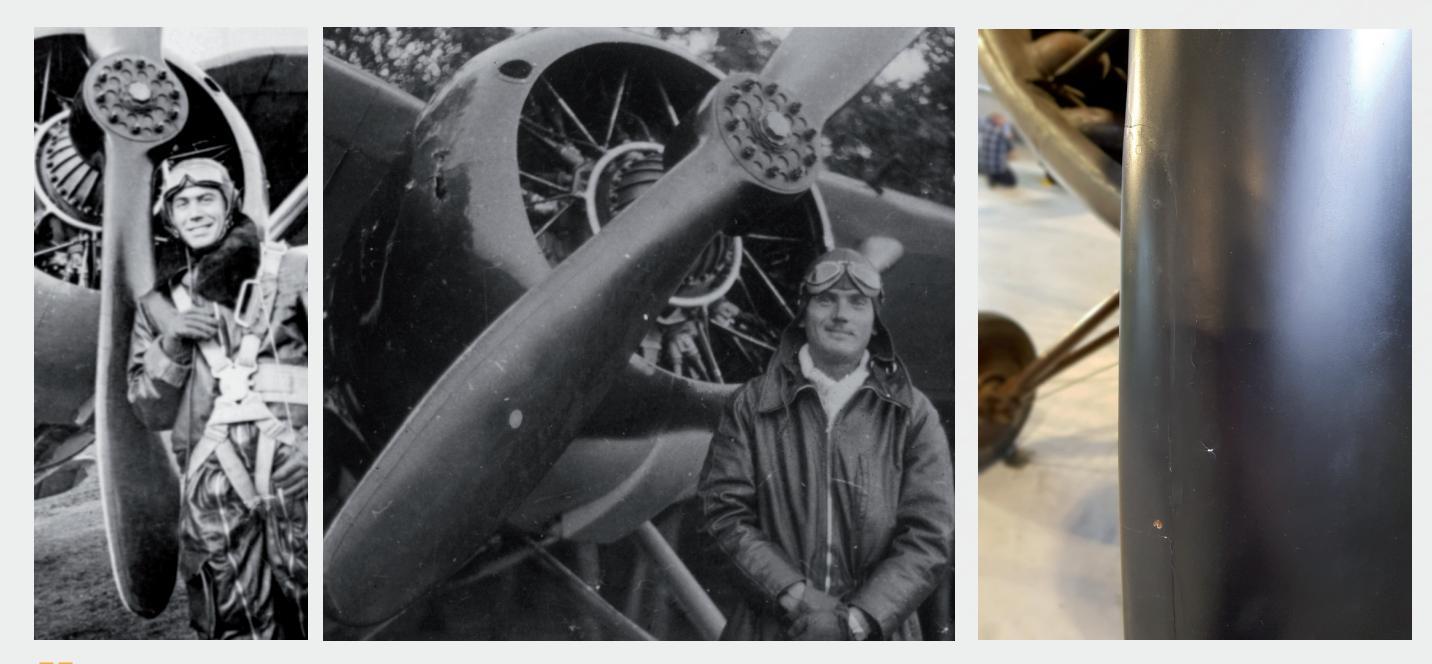
Left and centre - two more original photos of the propeller providing a good view at the metal leading edge protection consisting of the rectangular plates (apart from the top and bottom of the protection). At right – a nearly identical solution on the museum P.11c propeller. Centre photo shows the manufacturer decal in the middle of the blade. While it is generally accepted that P.11F originally used Szomański propellers, this decal does not fit the well-known logo of this company. If any of the Readers recognize it, author would be grateful for the contact. (Horia Stoica/Dan Antoniu collection, Michał Skawiński)

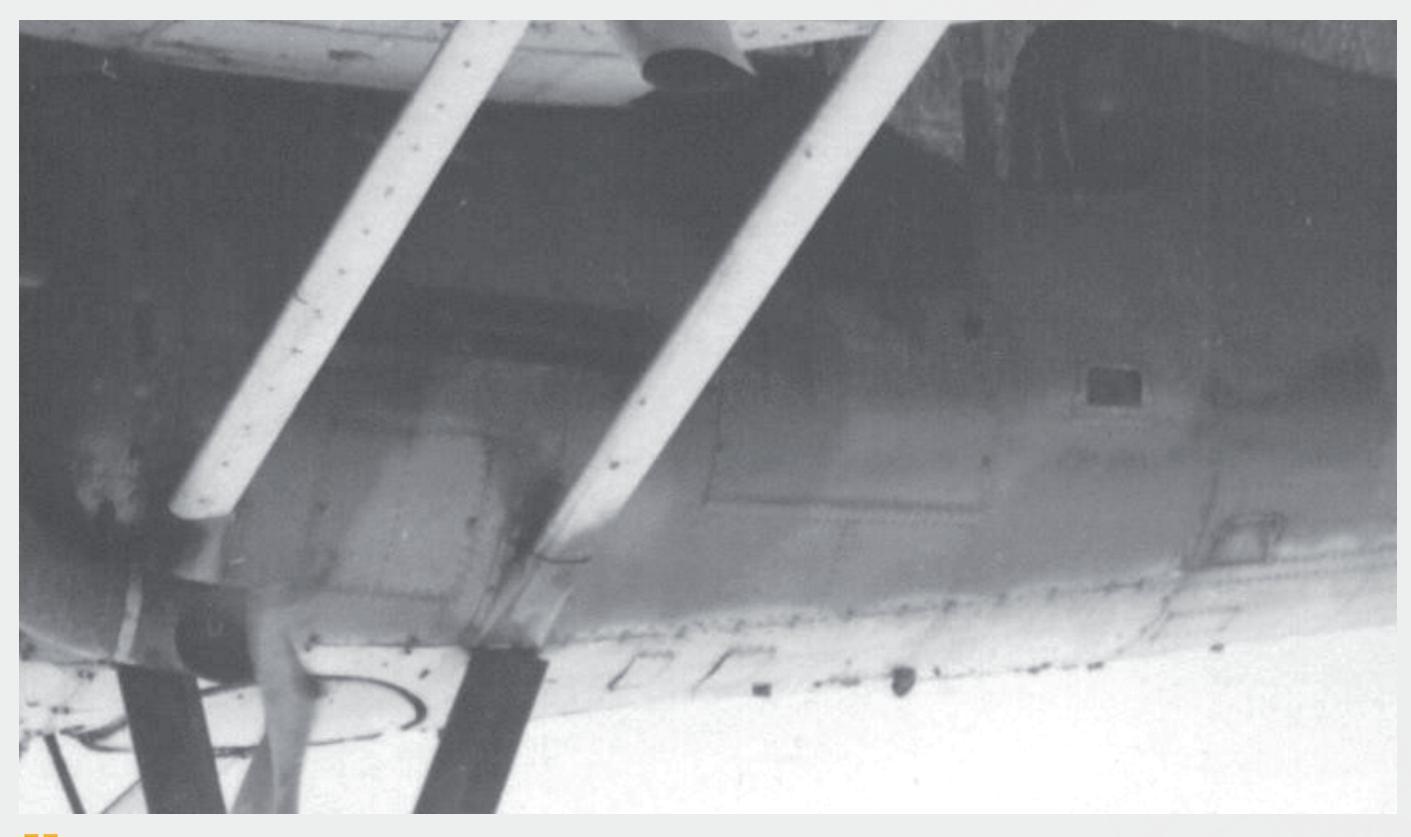
Front of the port side of the fuselage. Visible is an additional panel between the strut mounts (not present on P.11c) and details of the lower areas, usually staying in the shade. The tubular vent under the bottom of the cockpit was not present on all machines and its function is not known. (Horia Stoica/Dan Antoniu collection)

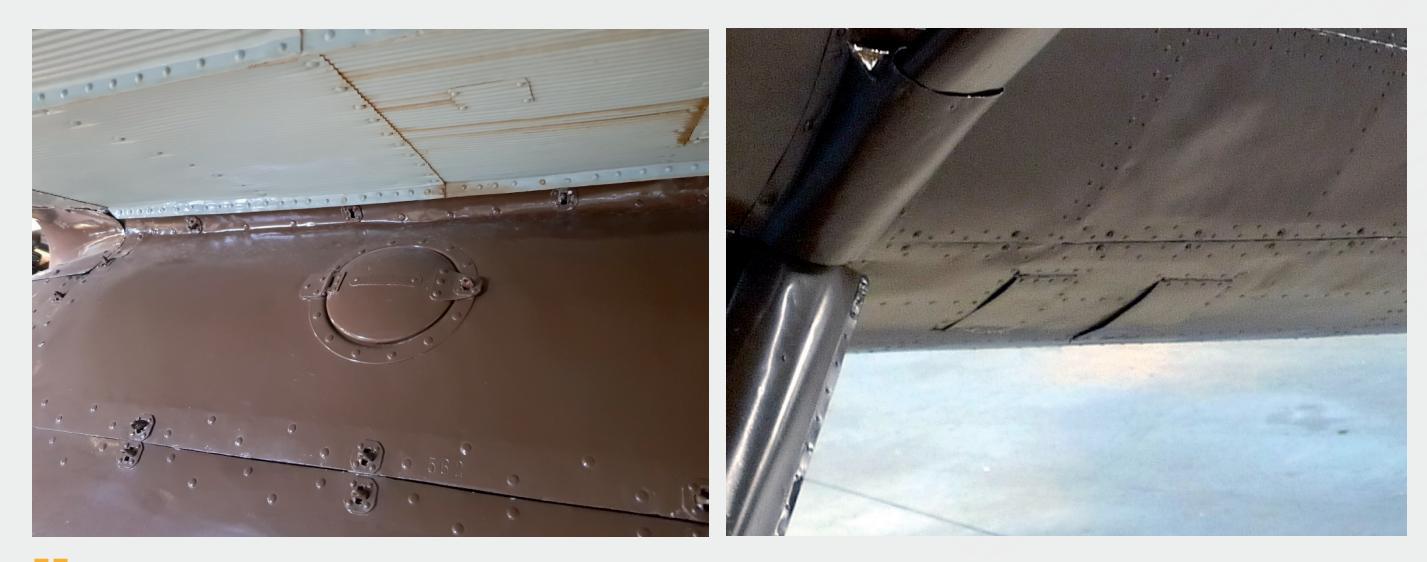
Two photos of museum P.11c showing elements identical on P.11F. At left - cover of the fuel filler cap under the wing. At right – opening panels of the spent links and cartridges containers. (Michał Skawiński)

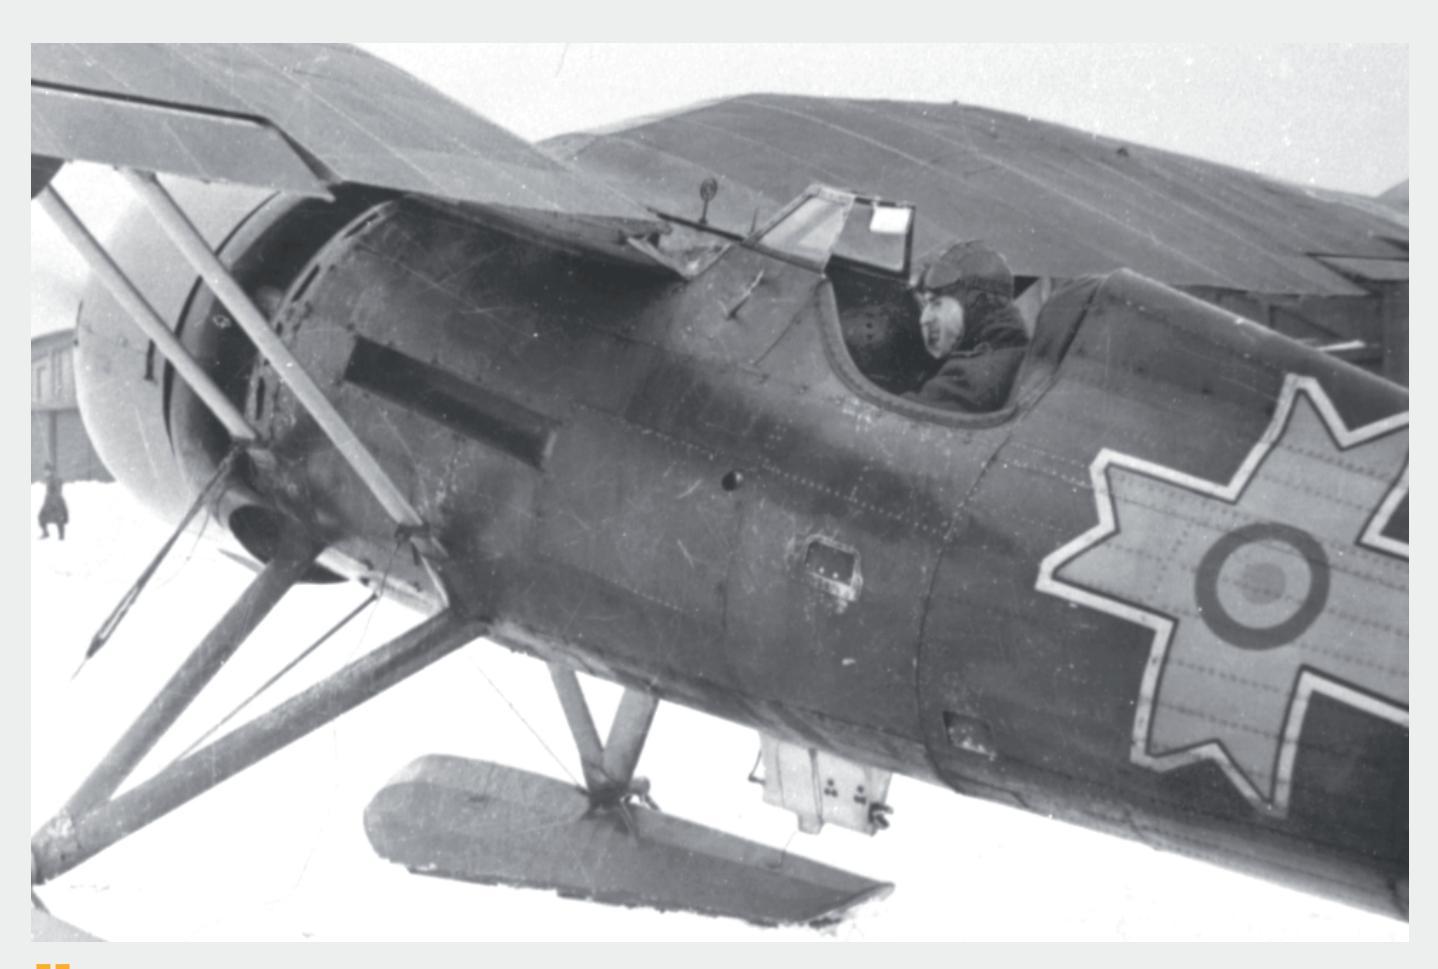
Similar view to the one presented earlier, but showing additional details. Note the access door behind the fuselage machine gun recess, two steps facilitating entering the cockpit, riveting of the fuselage and lack of opening panel above the rear, bottom step – one present on museum P.11c. (Horia Stoica/Dan Antoniu collection)

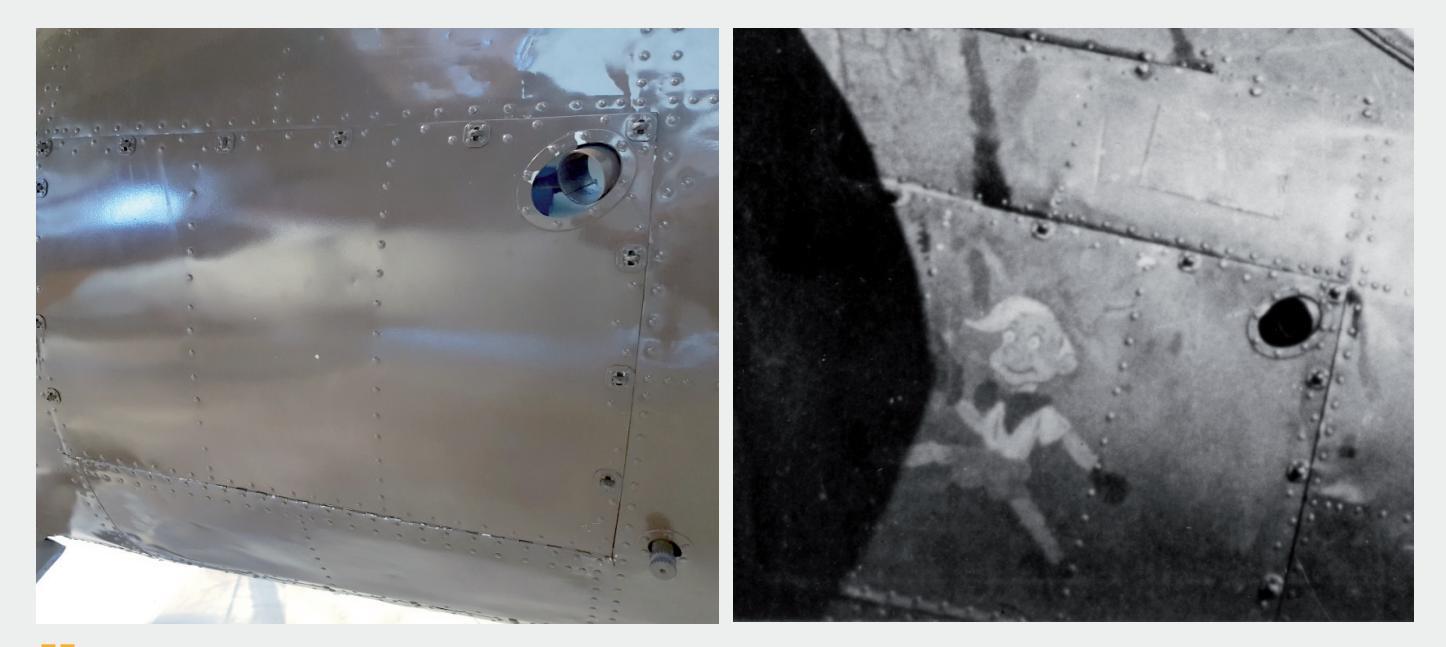
Machine gun access door on the port side of the fuselage. At left – museum P.11c. Right – P.11F. While they look extremely similar, P.11c had six locks in the top line, while P.11F only five. Note also slight differences in riveting. In the top right corner there is a signal pistol opening with the round clamp for holding it in place. (Michał Skawiński, Dénes Bernád collection)

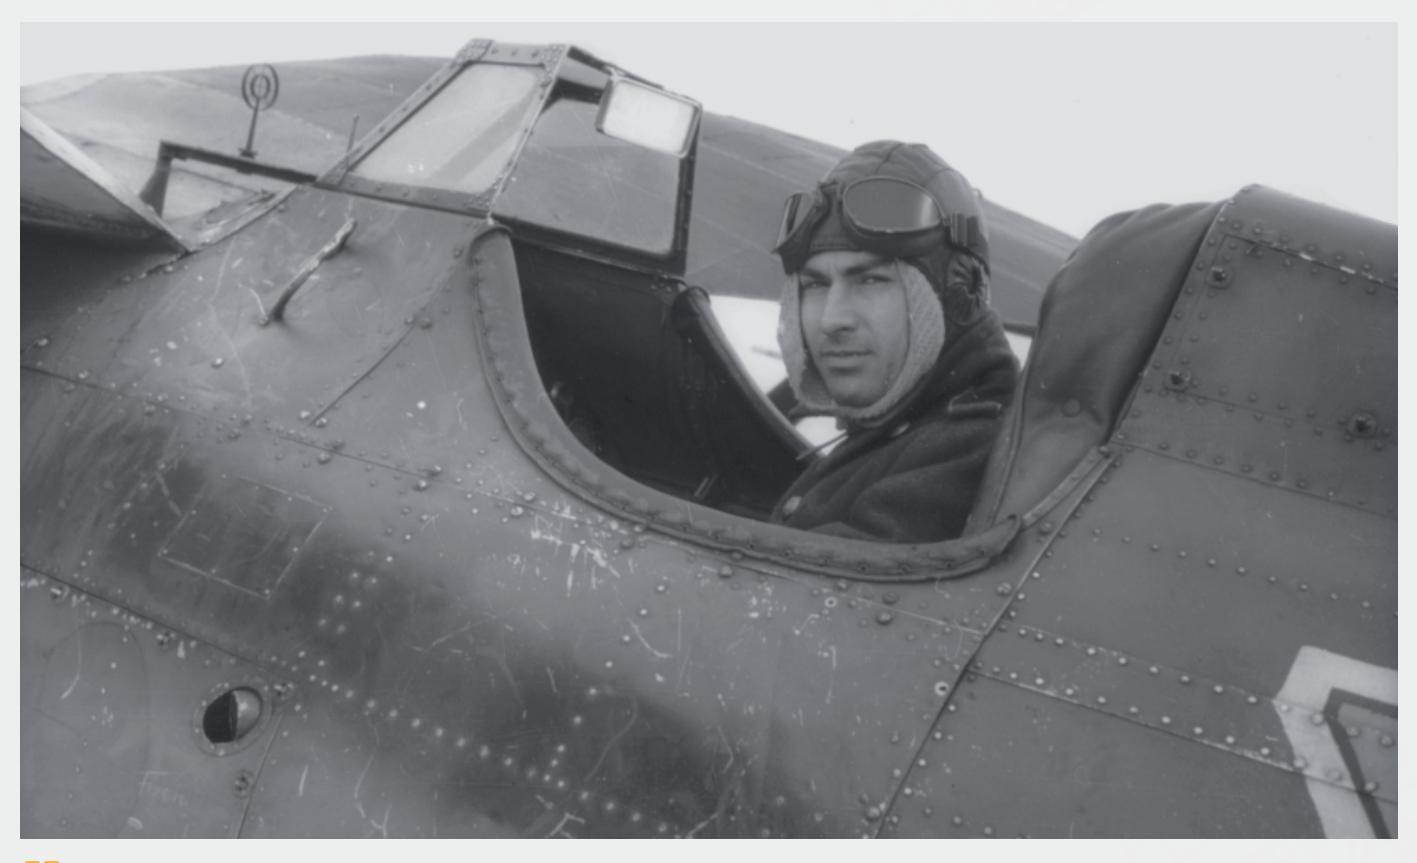
One more close up photo showing well the P.11F-specific gunsight in front of the windscreen (with a round cover beneath it), overpainted information plate fixed in place by nine rivets and the fact that top panels of the fuselage were held by screws, some of which are missing! (Horia Stoica/Dan Antoniu collection)

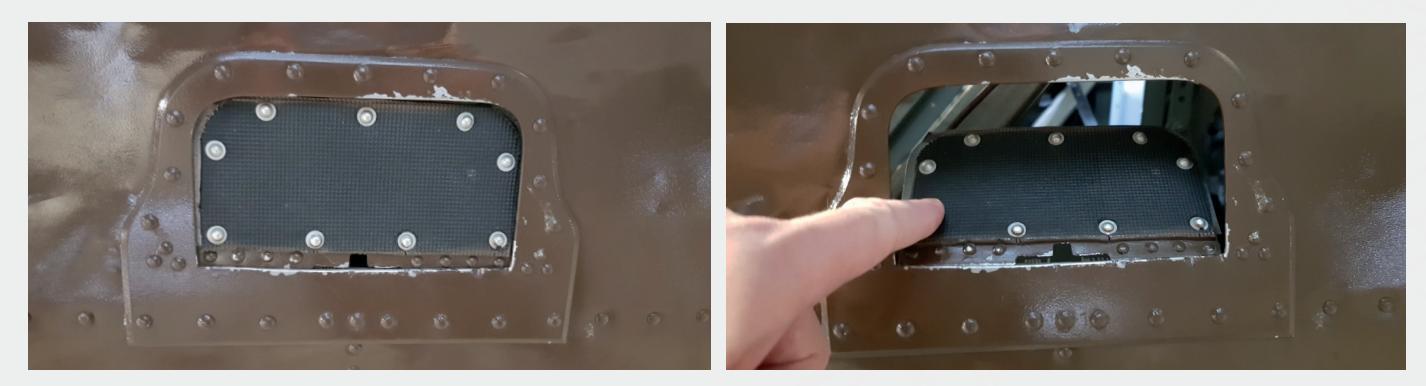
Top, forward step facilitating entering the cockpit of P.11c. Romanian version had identical ones. Note the black rubber facing, the rivets and the way the step opens. (Michał Skawiński)

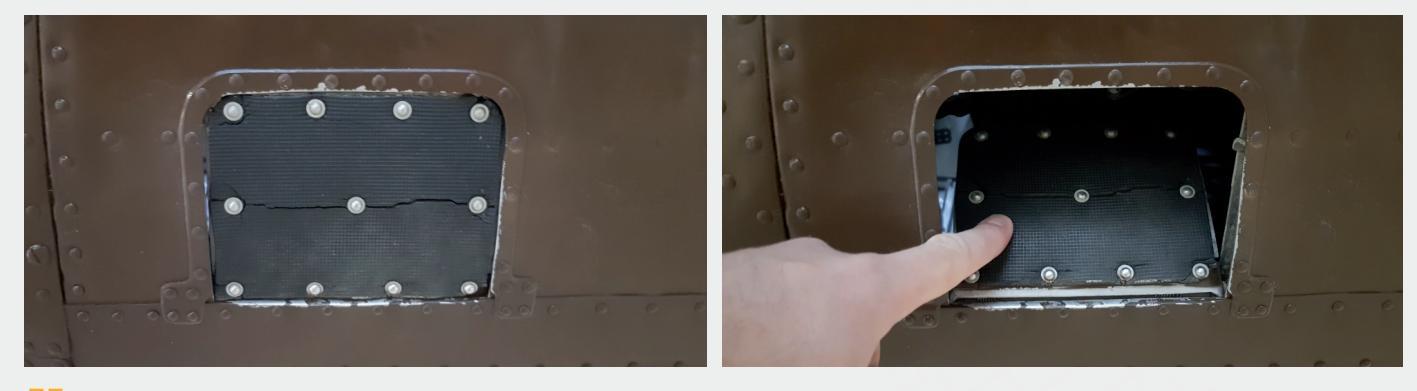
And two similar photos of bottom, rear one. The original photos quite often show the rubber facing well-worn and the natural aluminium visible in places. (Michał Skawiński)

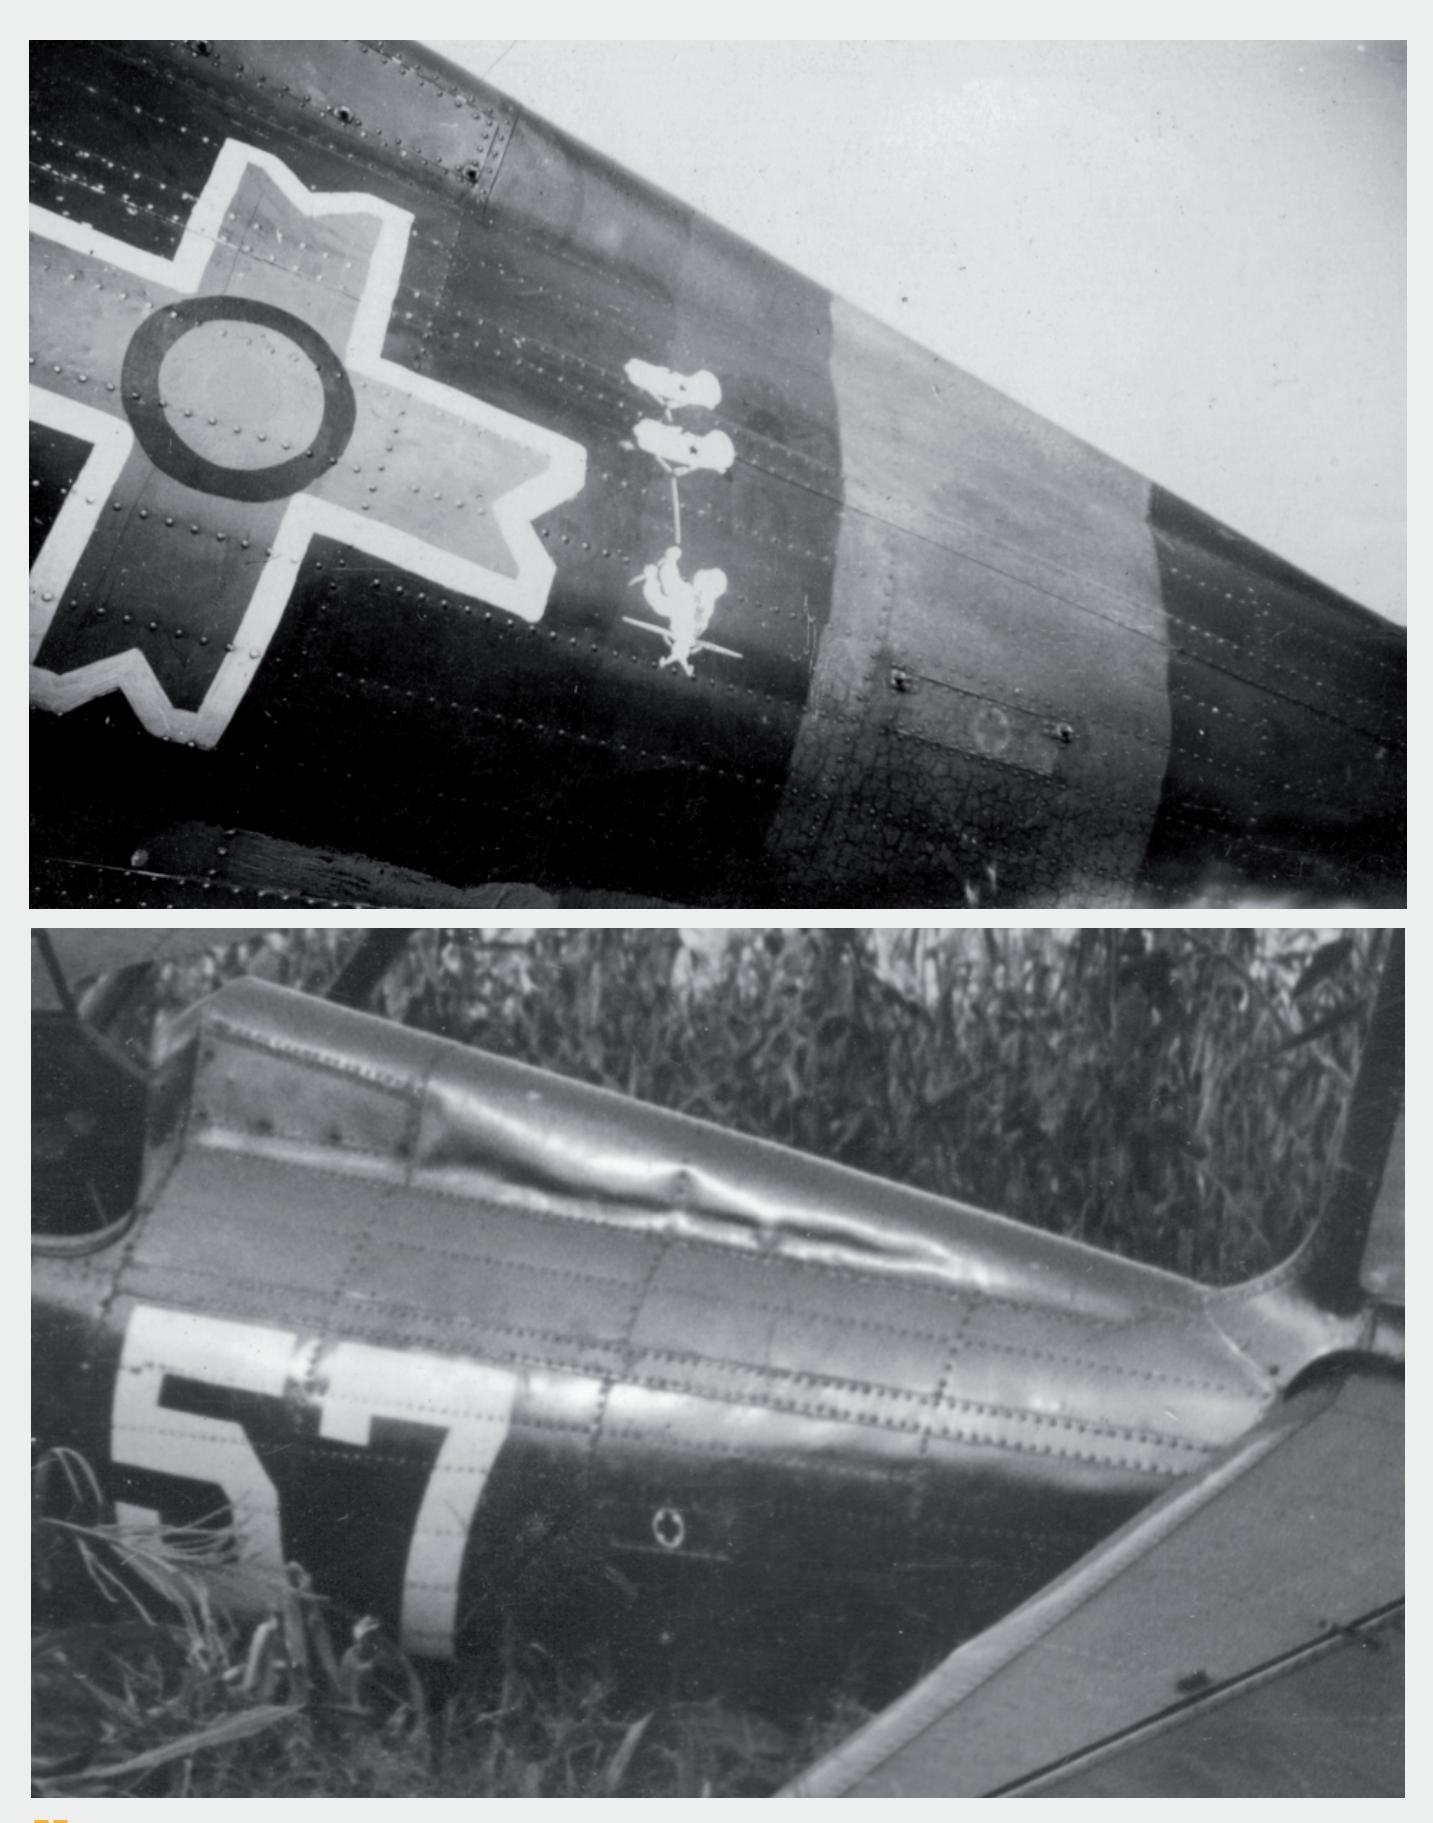
Semi-monocoque aft section of the fuselage. Immediately behind the headrest there is an opening panel of a luggage compartment. First aid kit compartment was marked with a red cross on a white circle. Note the riveting. (Horia Stoica/Dan Antoniu collection)

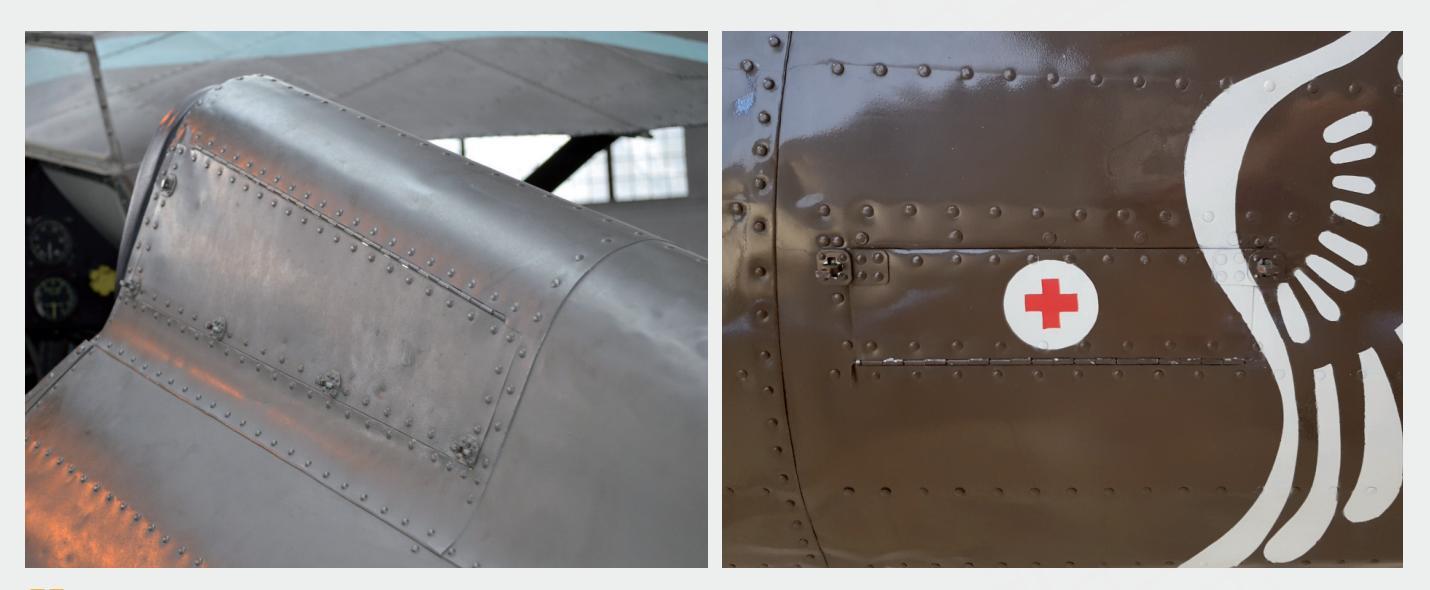
Luggage and first aid compartments in the museum P.11c. P.11F had identical ones down to a single rivet. (Marek Możdżeń, Michał Skawiński)

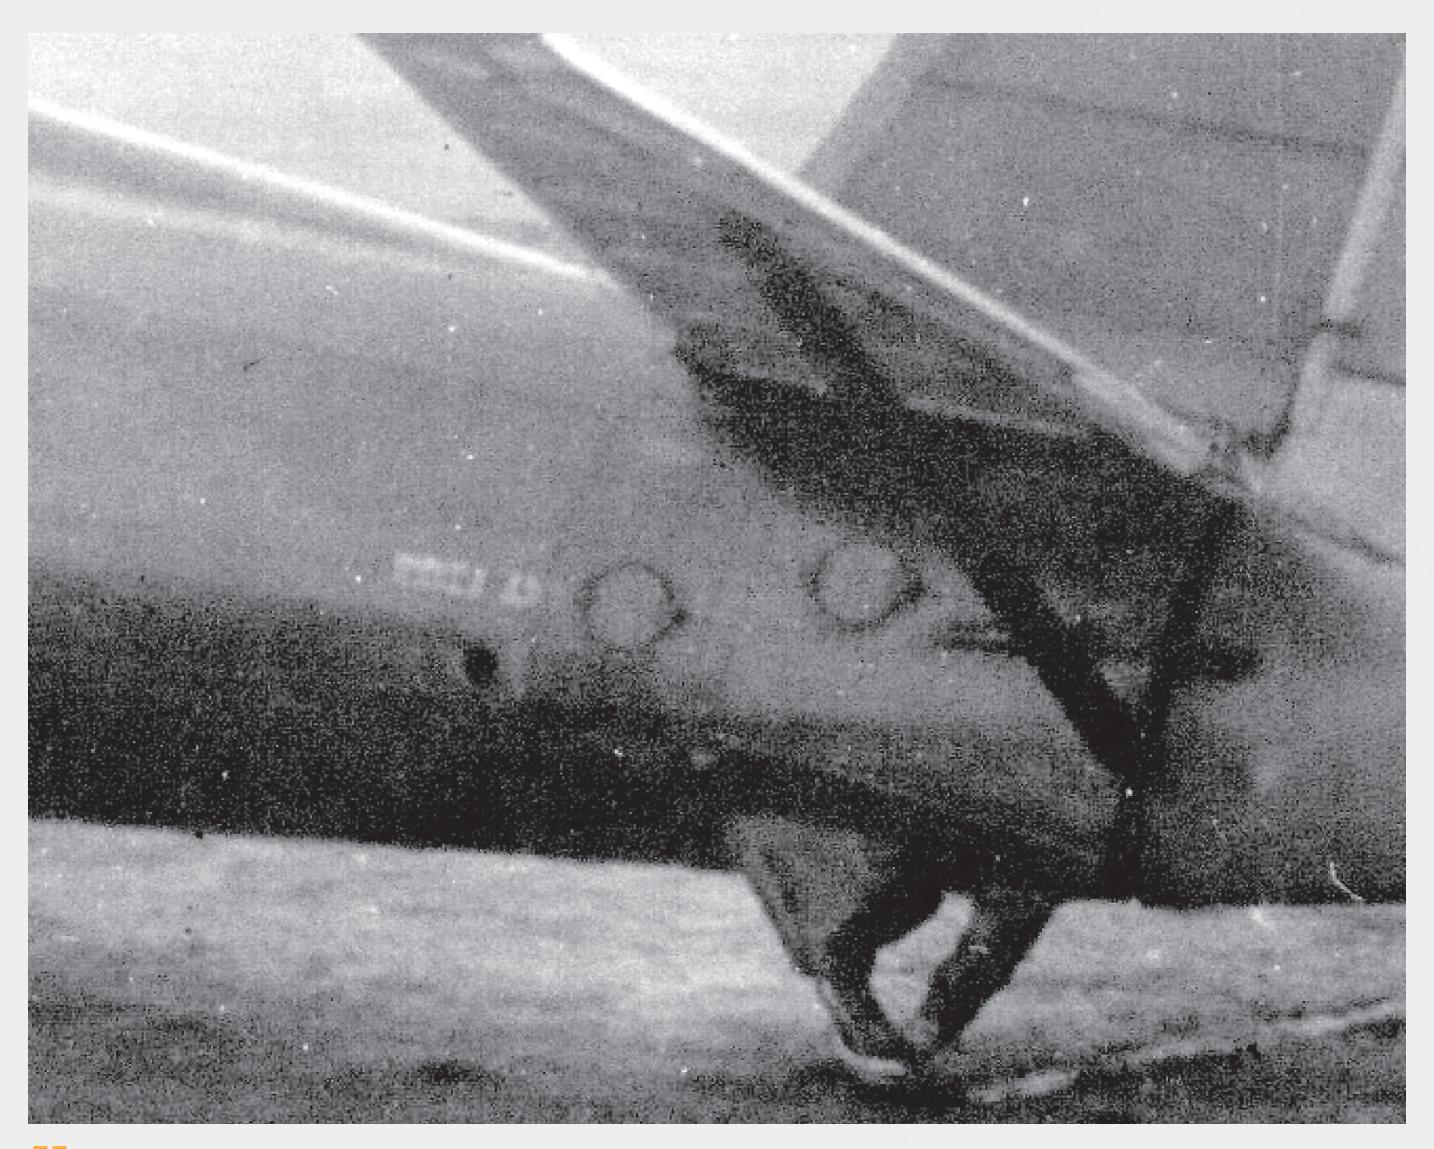
Not a very sharp photo of P.11F, but showing well the two round inspection panels below the horizontal stabilizer. Further to the front there is a hole into which a rod was put in order to lift the tail of the airplane. (Horia Stoica/Dan Antoniu collection)

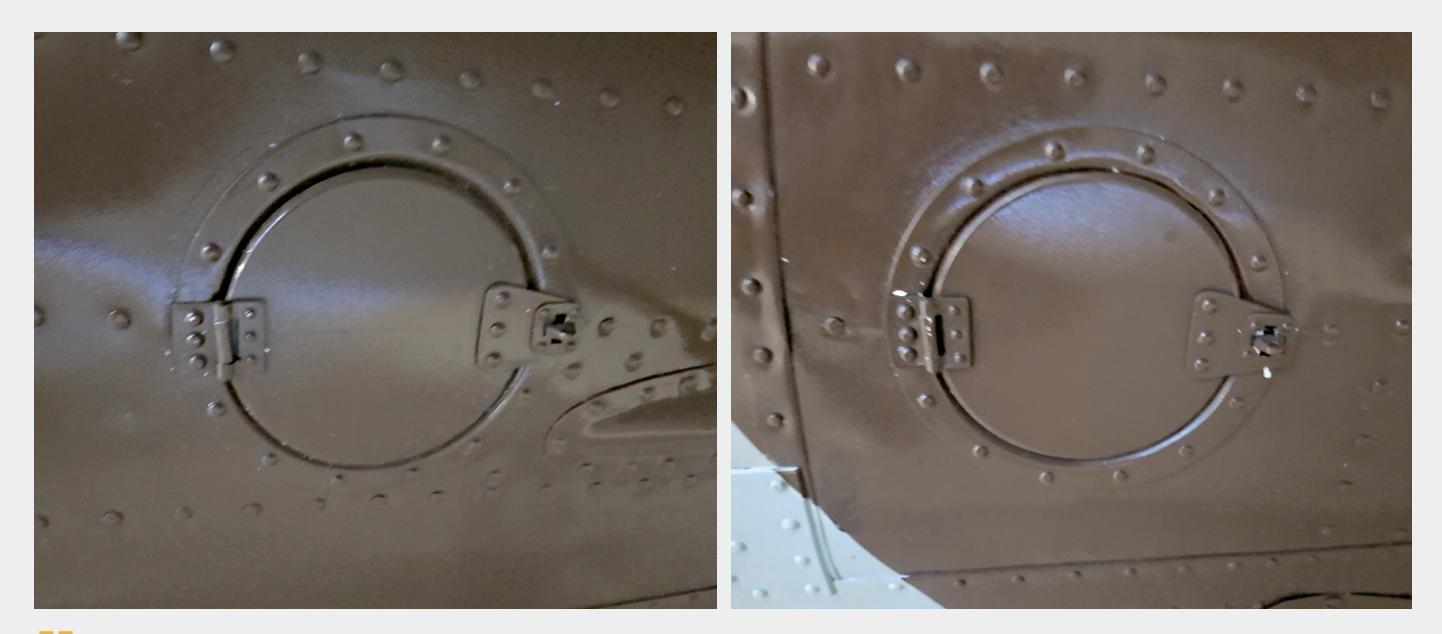
Close up of the museum P.11c round inspection panel. Again, exactly the same ones were on P.11F. Left – front one, right – rear one. (Michał Skawiński)
