P11F REDISCOVERED

Michał Skawiński

History of the Type

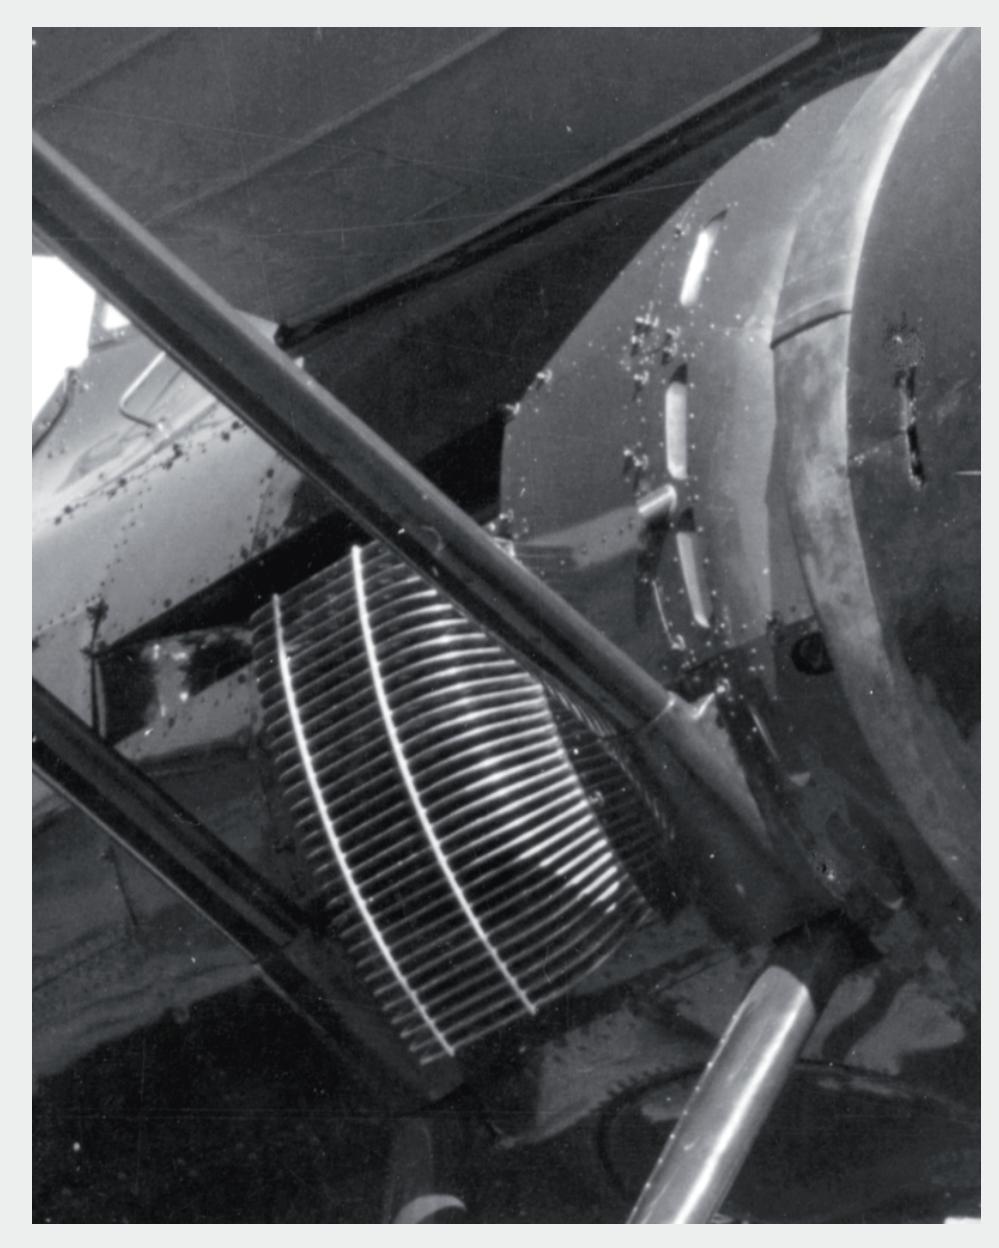
Front of the starboard side offering a wealth of details. Worth noting are the skin details with locks and rivets and the radiator with 30 ribs (as opposed to 24 ribs in P.11c), installed on at least some if not majority of P.11F produced. (Tomasz Kopański collection)

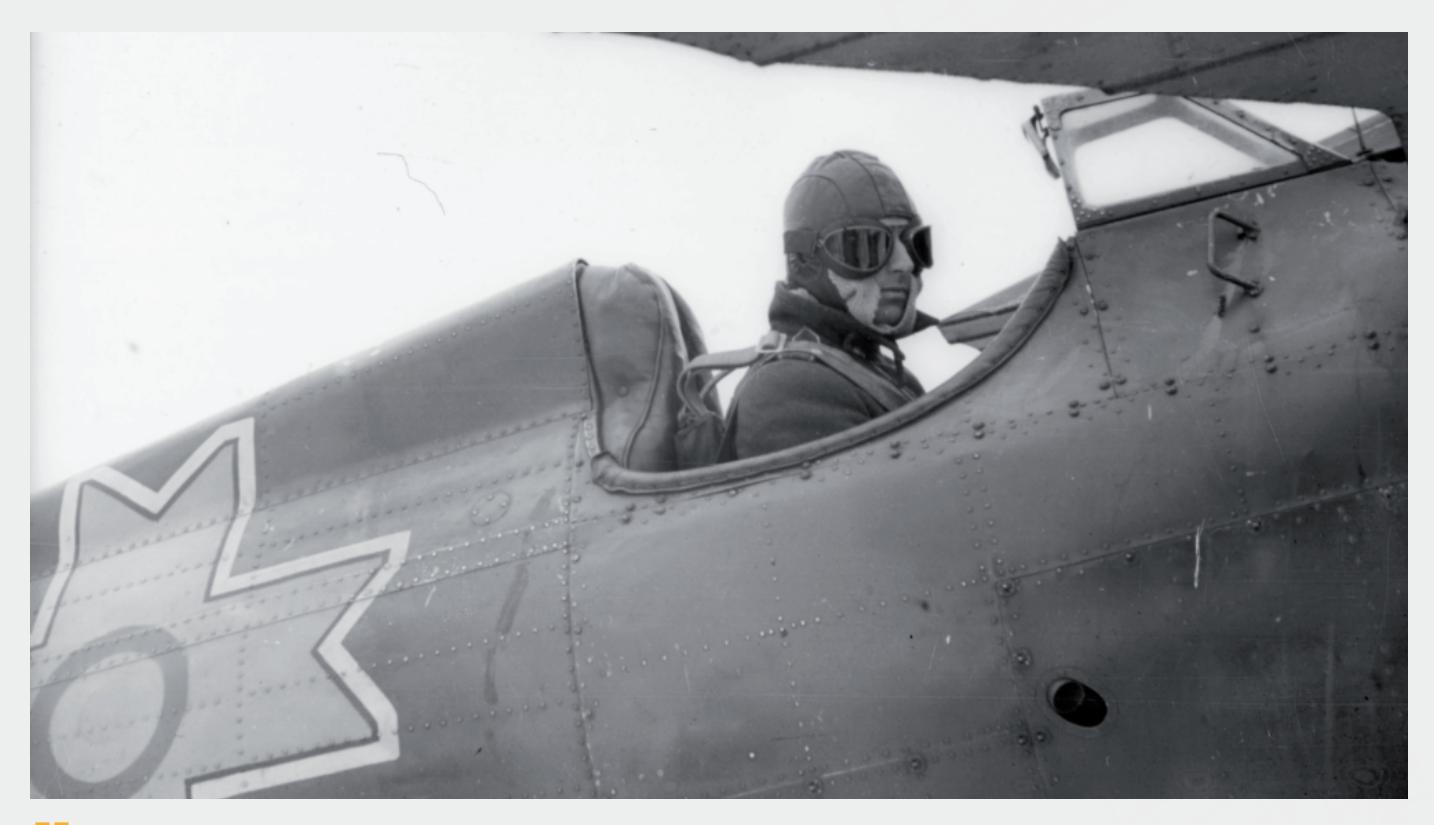
Further to the rear. This airplane had a round cover in place of the antenna insulator (compare with the photo below). Again, note the screws and not rivets were holding the panels around the cockpit in place. This significantly facilitated overhauls, as they could simply be unscrewed to allow a very good access to the truss sections of the fuselage. (Horia Stoica/Dan Antoniu collection)

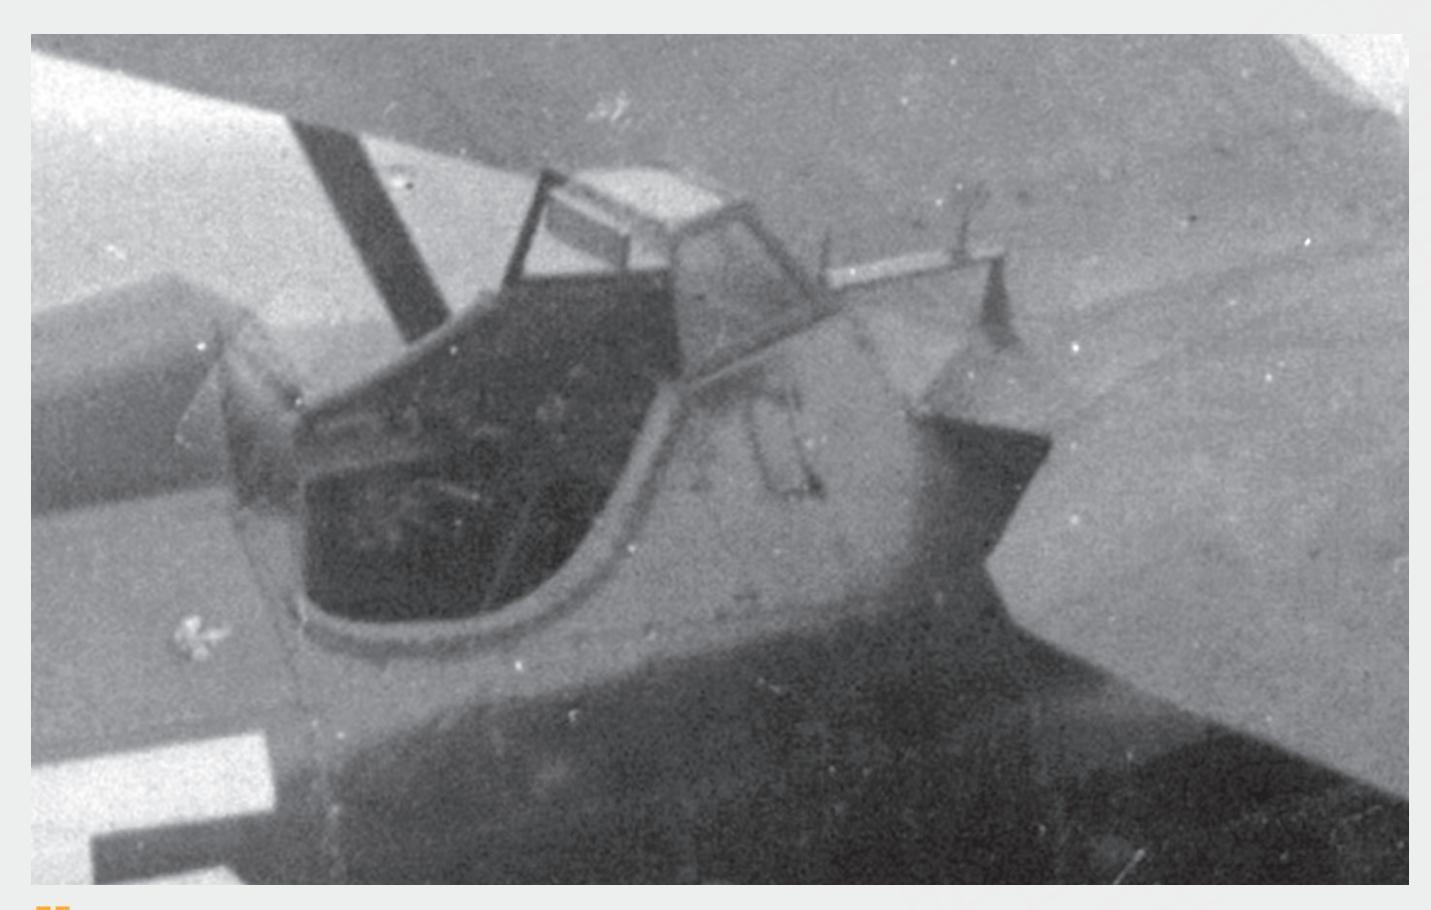
Blurry, but an important view of the starboard side. Note the shape of fairing in front of the windscreen, just below the gunsight – this area differed from P.11c. (Horia Stoica/Dan Antoniu collection)

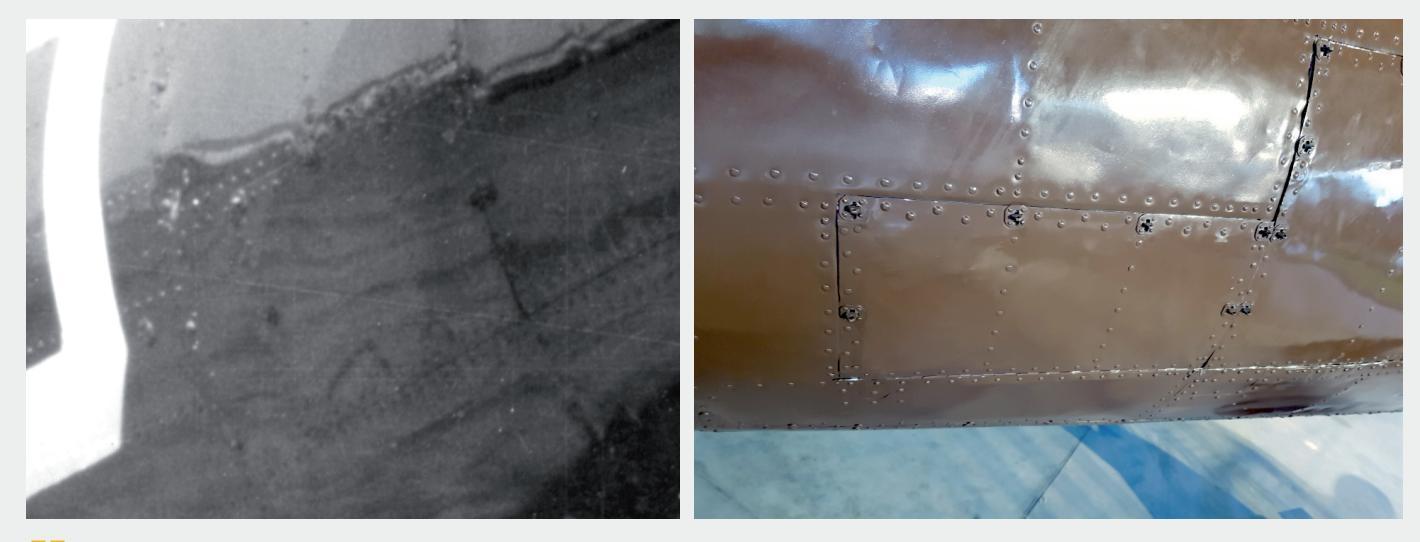
Oxygen bottle access panel directly behind the machine gun access door. Left – on the P.11F No. 70. Right – museum P.11c. This time number of locks is the same, but riveting shows slight differences. (Tomasz Kopański collection, Michał Skawiński)

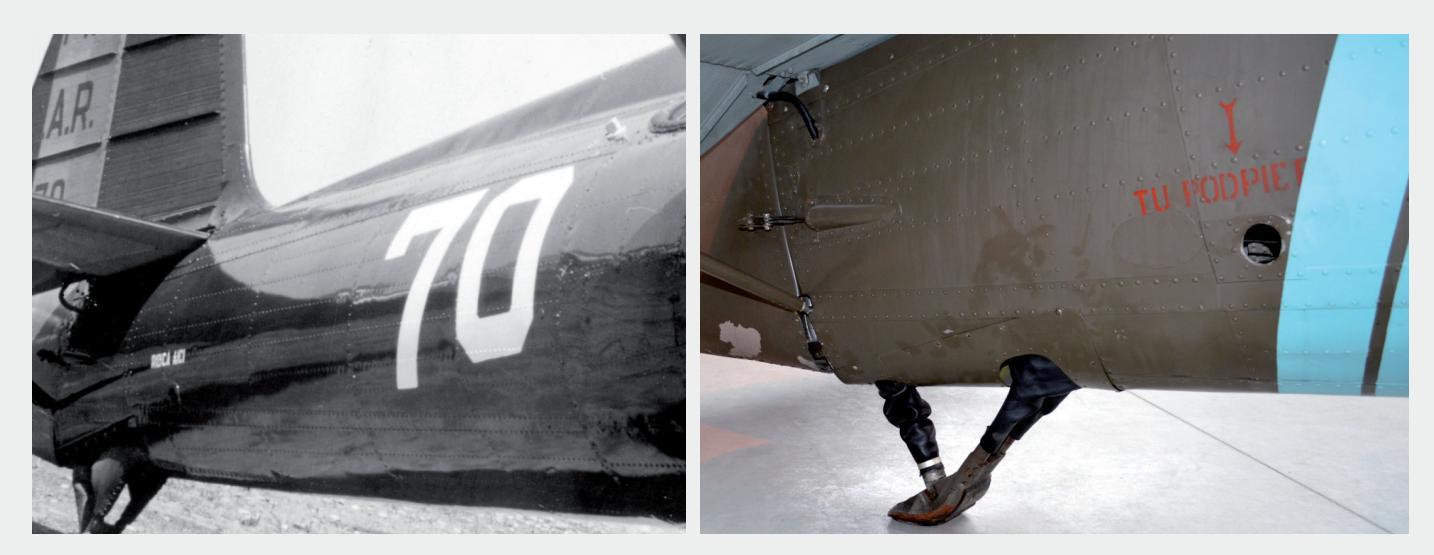
Rear starboard fuselage. Again, the photo of P.11F No. 70 at left provides a wealth of details. Clearly visible is the lack of the Venturi tube present on P.11c. There is a circular element just to the right of the bottom of number 0. Its purpose is not known. Further to the rear there is a hole with 'Ridică aici' (Lift here) stencil above it. Right – rear fuselage in P.11c, identical to P.11F. (Tomasz Kopański collection, Marek Możdżeń)

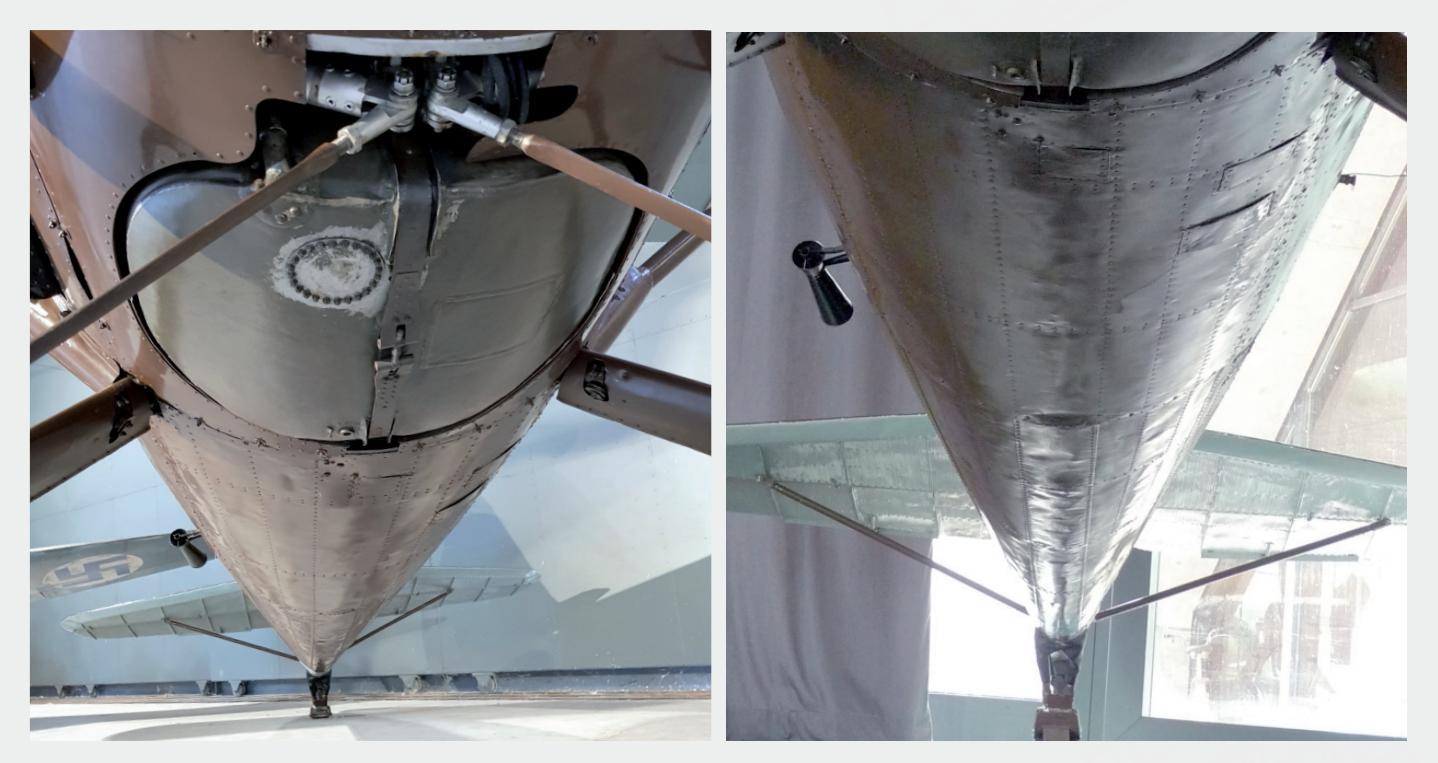
Bottom of the museum P.11c fuselage. The most prominent feature was the fuel tank that could be dropped in an emergency, a feature common for both P.11c and P.11F. Other elements of the fuselage underside were also largely similar between the two versions. (Michał Skawiński)

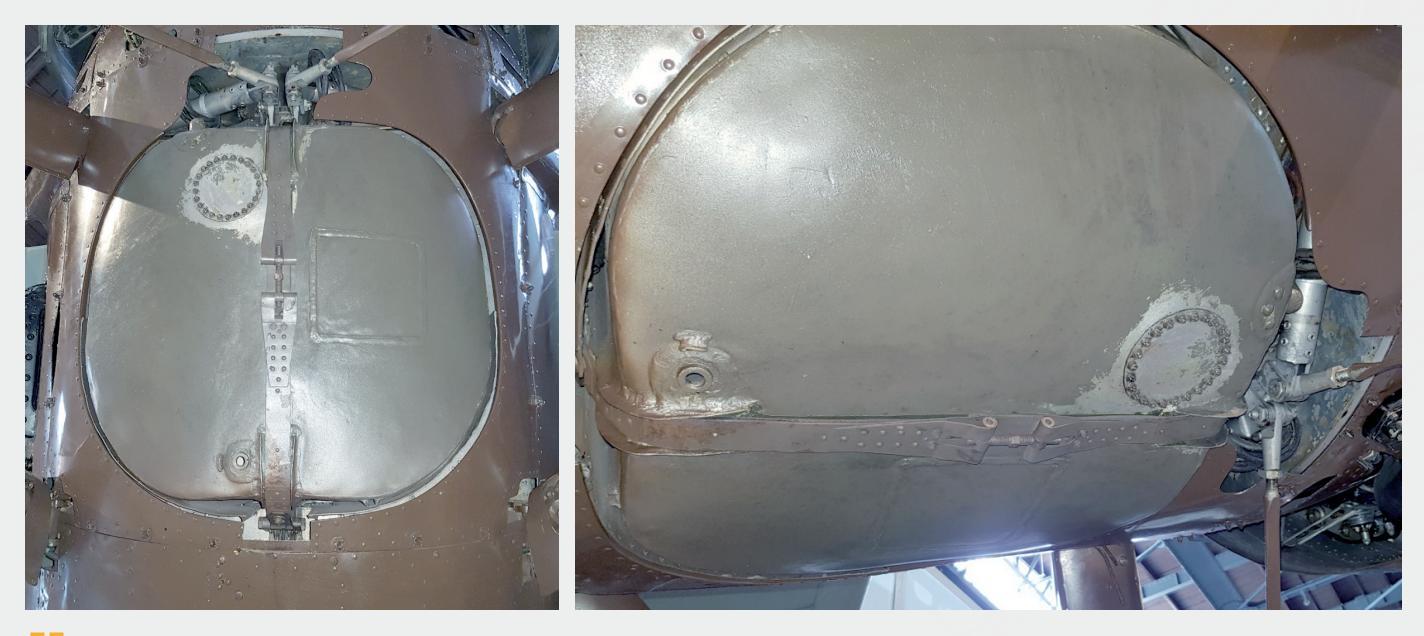
Close ups showing the fuselage fuel tank details. Note the belt running in the middle – releasing it caused the fuel tank to drop from the airplane. (Michał Skawiński)

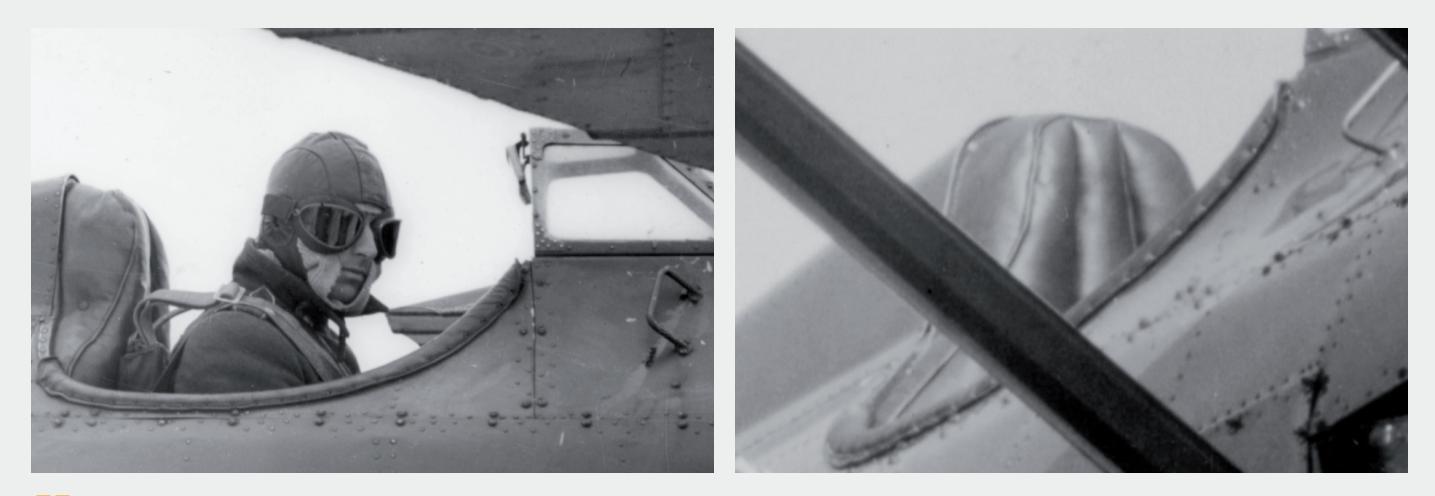
External areas of the cockpit. Note the leather headrest and cockpit sides. Well visible are also rivets of the windscreen and handles at the sides of the cockpit. (Horia Stoica and Tomasz Kopański collections)

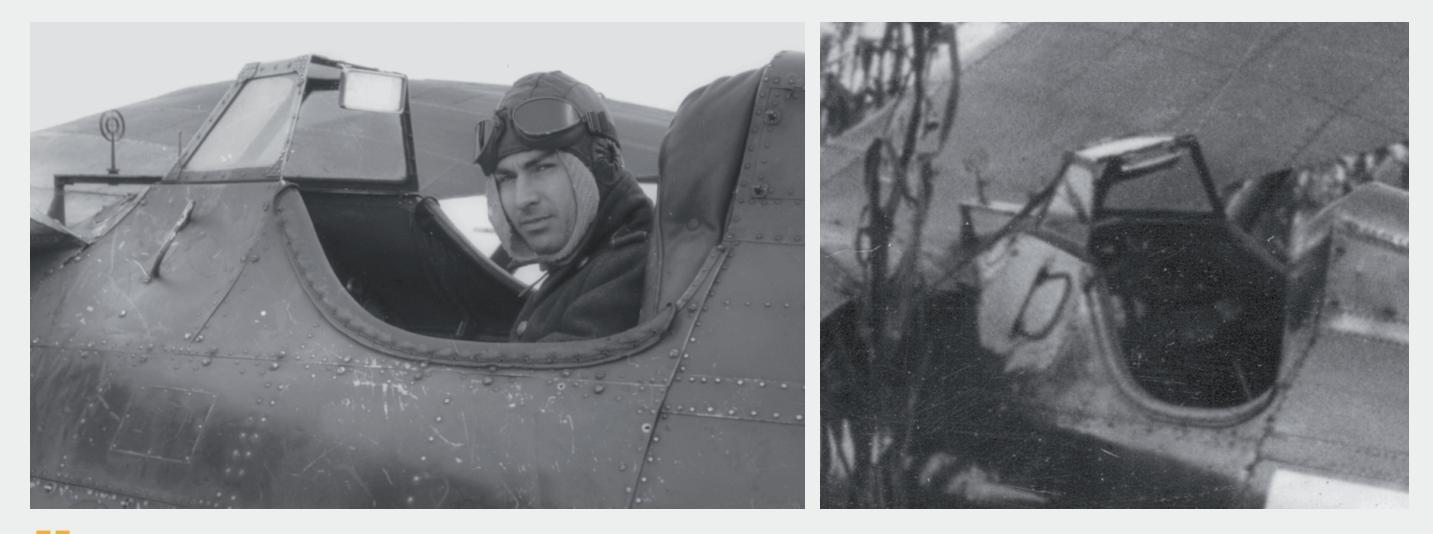
Similar view, but from the port side. Note the rear-view mirror and gunsight details. In the photos (and the next photo below) well visible is the fact that there was no sunscreen above the instrument panel. Cockpit interior was painted silver, at least initially. (Horia Stoica/Dan Antoniu collection)

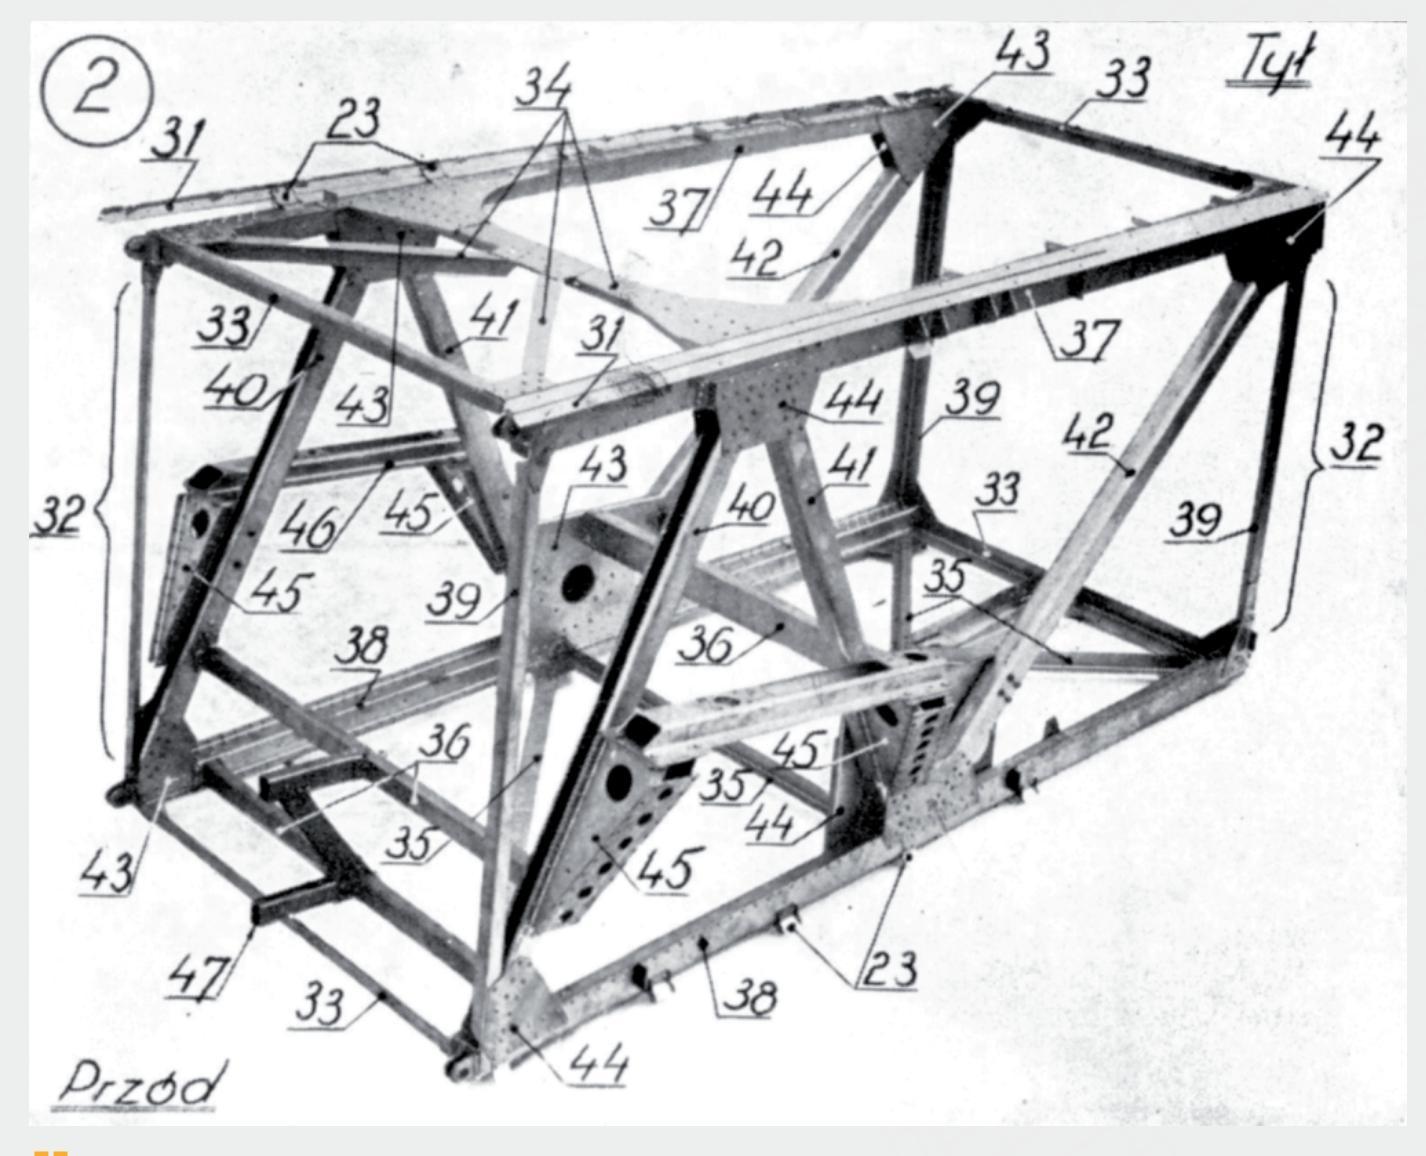
Truss section of the cockpit area. Fuselage machine guns mounts consisted of elements number 45 and 46. The word 'Przód' (Front) clarifies the orientation. (Muzeum Lotnictwa Polskiego)

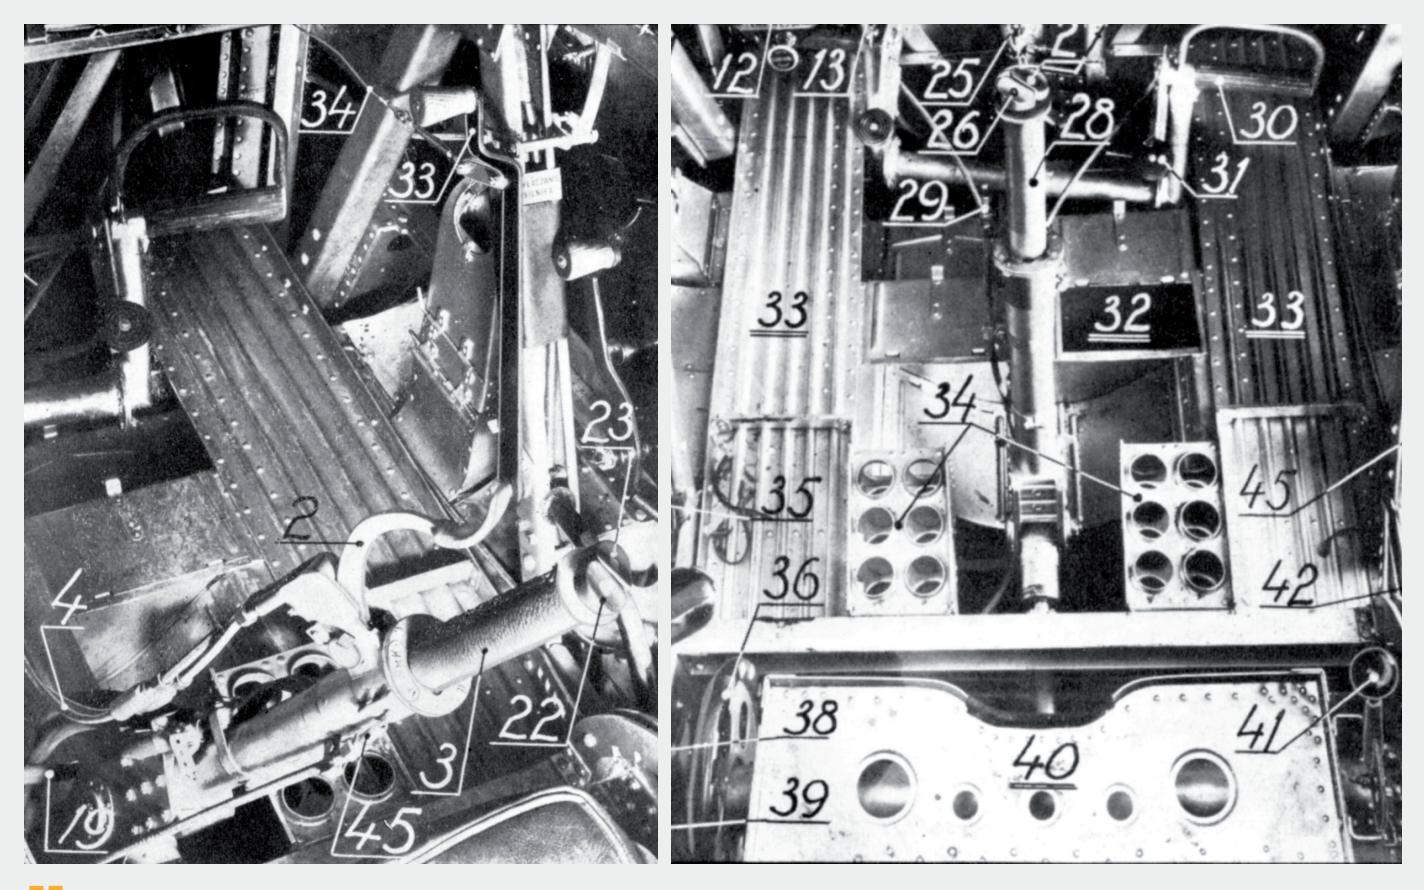
Two more photos from the P.11c manual showing the cockpit floor. Note the control stick (3/28), rudder pedals (30), signal pistol cartridge rack (34), ammunition boxes (32) and finally flooring itself (33). It is reasonably safe to assume these elements were identical in P.11F. (Muzeum Lotnictwa Polskiego)

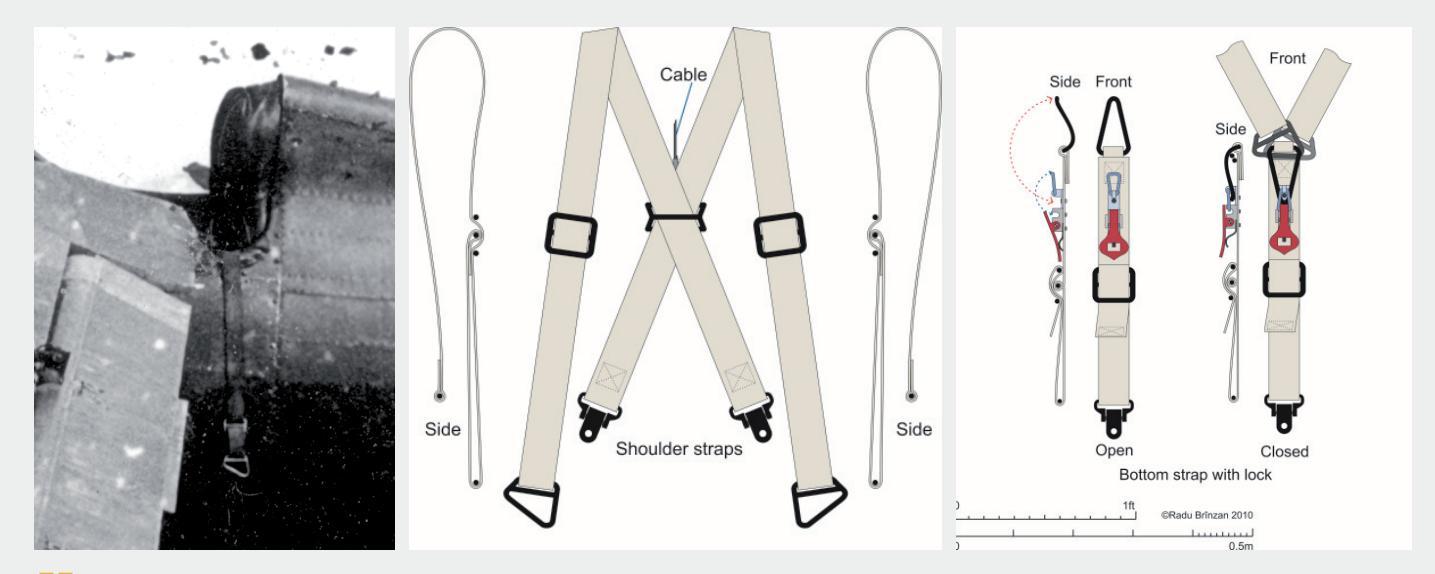
Photo at left proves that P.11F had Romanian harness, at least later in the service. As opposed to the Polish one it did not go over the seat, below the headrest, but rather went through the bottom of the backrest in the seat. Drawing at right shows the details of the type of harness that was continued through P.24E and into IAR.80. (Horia Stoica/Dan Antoniu collection, Radu Brînzan)

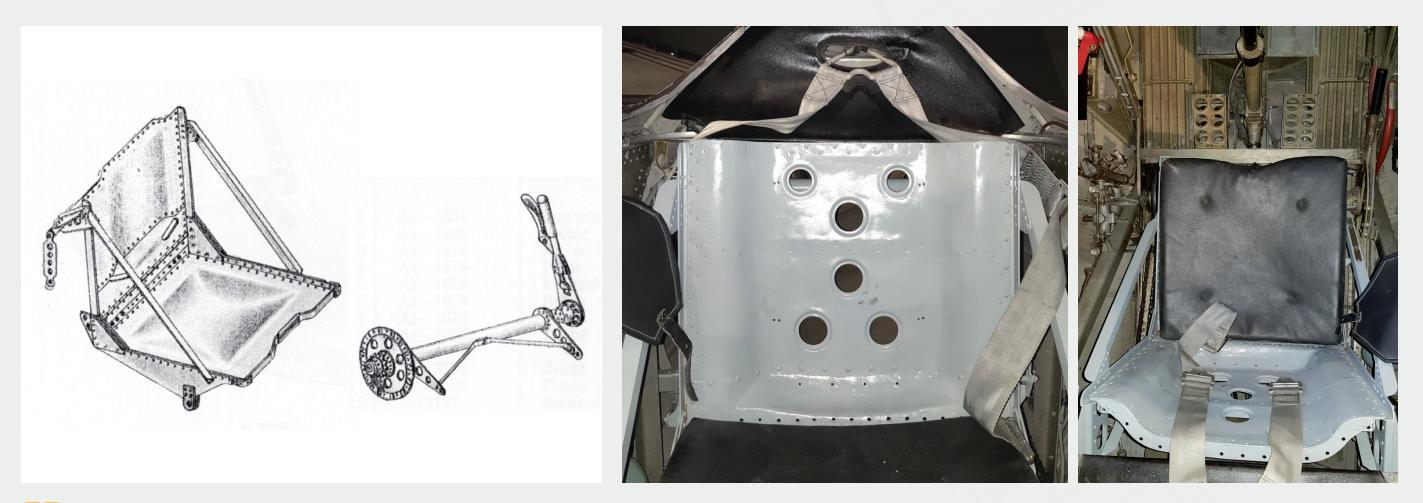
At left, drawing of the P.24E seat. Note the diagonal cut outs in the bottom of the backrest, through which harness was passing to the attachment points in the back of the seat bottom – P.11F must have had similar or identical ones. Above them a leather backrest lining is visible, typical also for P.11c (although not fitted to the museum example). Mechanism shown allowed for the regulation of seat height (handle) and adjusting the elevator trim (wheel). Photo in the centre shows the seat in the museum P.11c viewed from the front – note the missing lining on the backrest (allowing to view the perforations) and the lack of the diagonal harness pass-throughs typical for Romanian version (on Polish machines harness was passing below the headrest, as shown in the photo). Right – P.11c seat viewed from the top. Seat cushion is not original. Viet starter (visible to the left of the seat) was not installed in P.11F. (Radu Brînzan collection, Michał Skawiński)

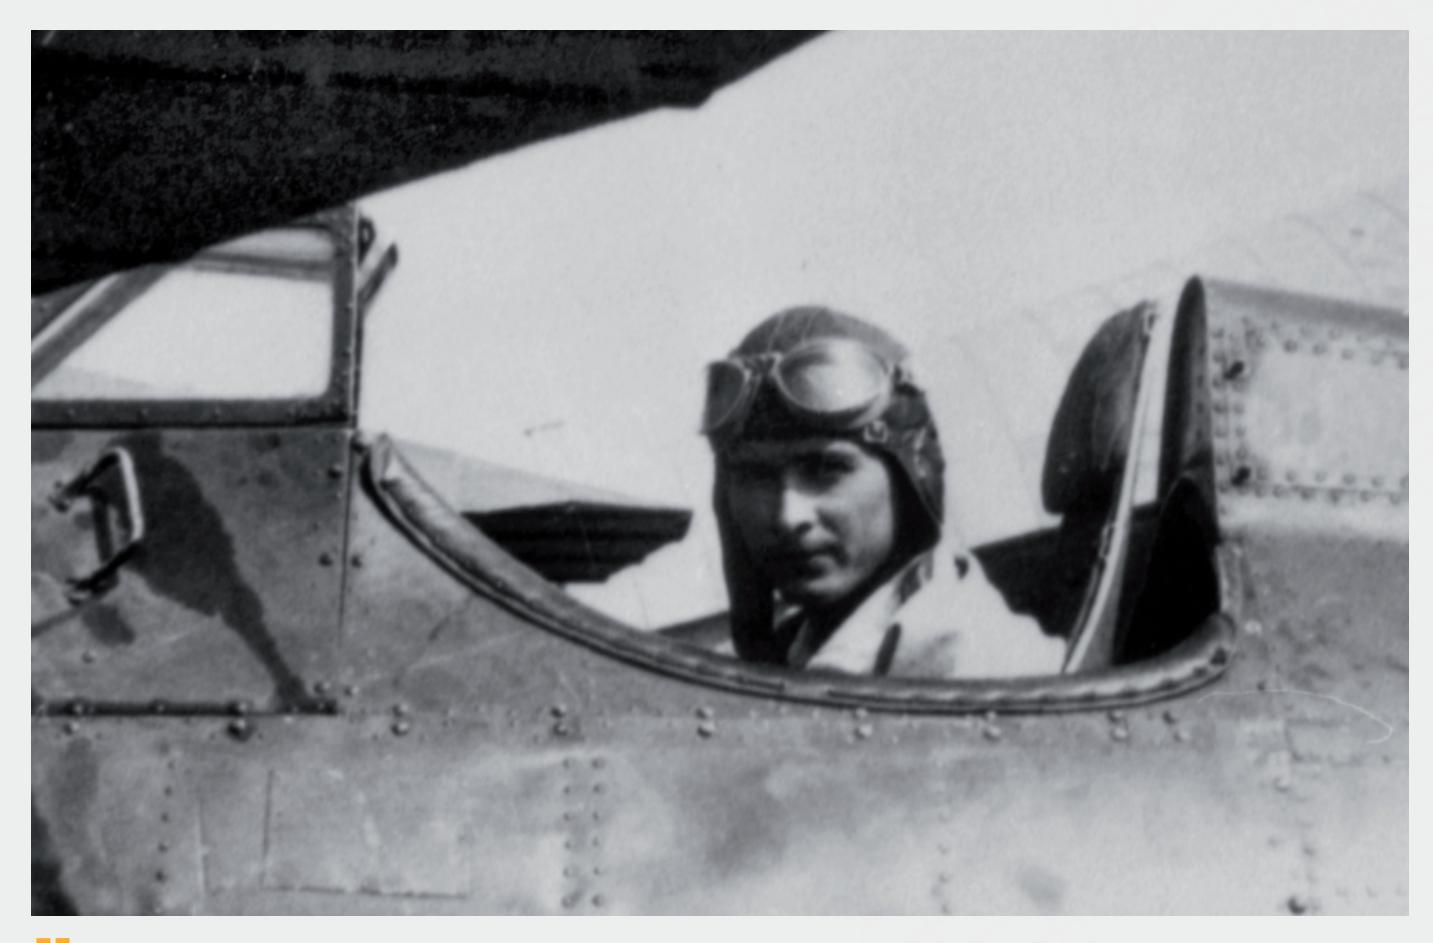
Some of the P.11F were equipped with armoured seat before or during the Barbarossa campaign. Original seat and headrest were removed and most likely entirely new, armoured seat with integrated headrest was installed. (Dénes Bernád collection)

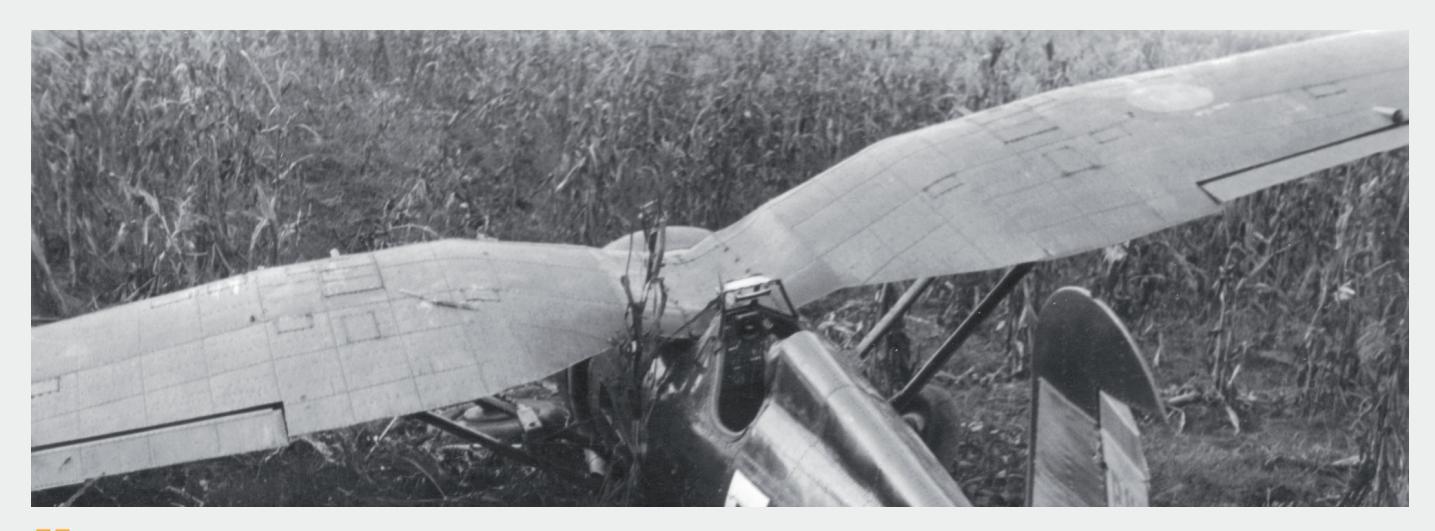
A good view on the complex, but elegant shape of Puławski's gull wing as used in P.11F. All the elements visible in this view were identical with the P.11c wing. Note the surface details (rivets, access panels) and the fact that panels directly in front of the cockpit and first one to each side were not covered with corrugated skin, but the smooth one. (Horia Stoica/Dan Antoniu collection)

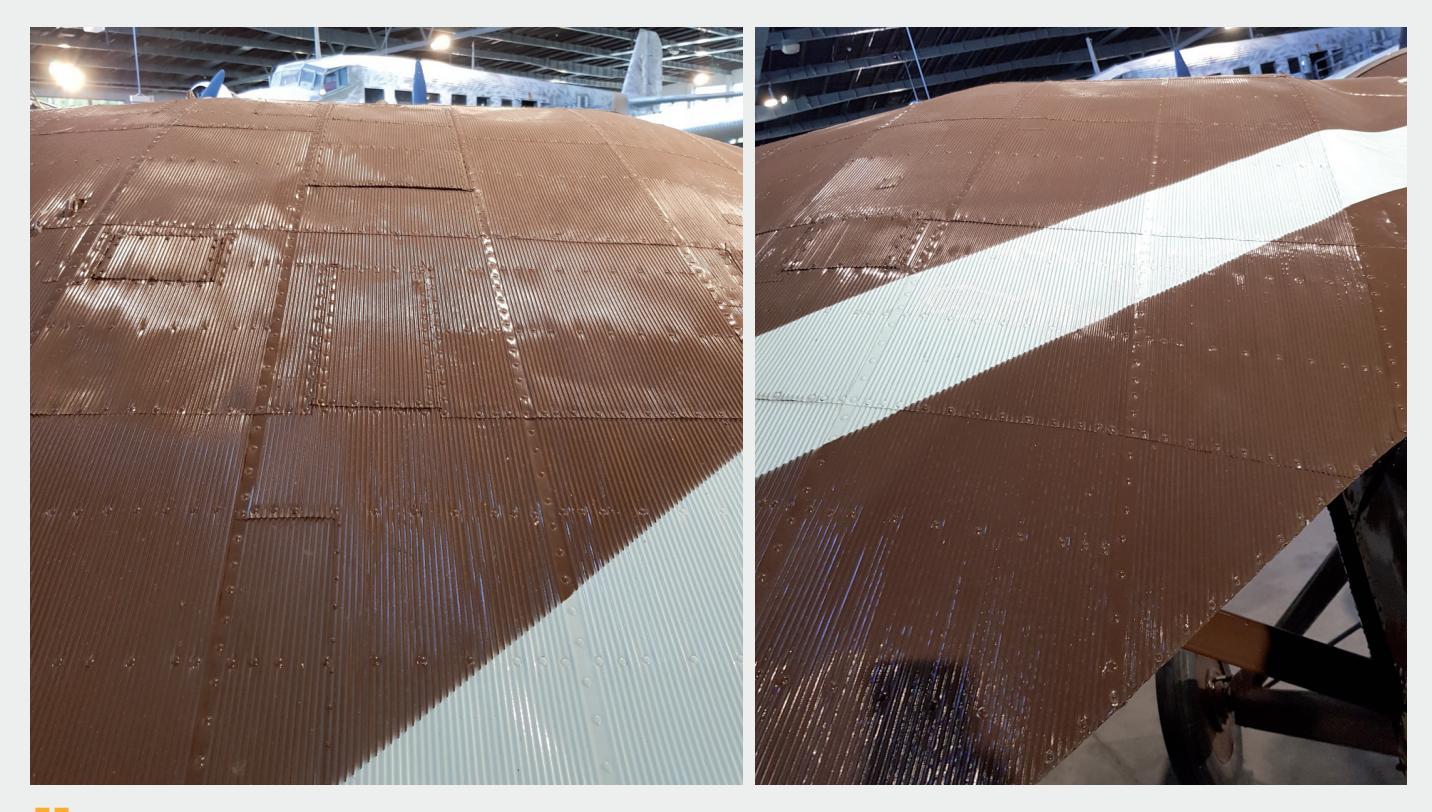
Close up on the port wing surface. Left photo – machine gun bay covers (top) and area aft of it. Skin repair is visible at the bottom (cuts in the corrugations and additional small rivets) – it was not present on the factory-fresh airplane. Photo at right – neighbouring area, closer to the fuselage. Apart from the corrugated surface there is a smooth skin visible to the right (mentioned in the description of the photo above). Of special interest are the details of the corrugated skin panels, each of them had an approximate width of 28 cm. The joints running along the wing chord were smooth, with a single line of rivets. (Michał Skawiński)

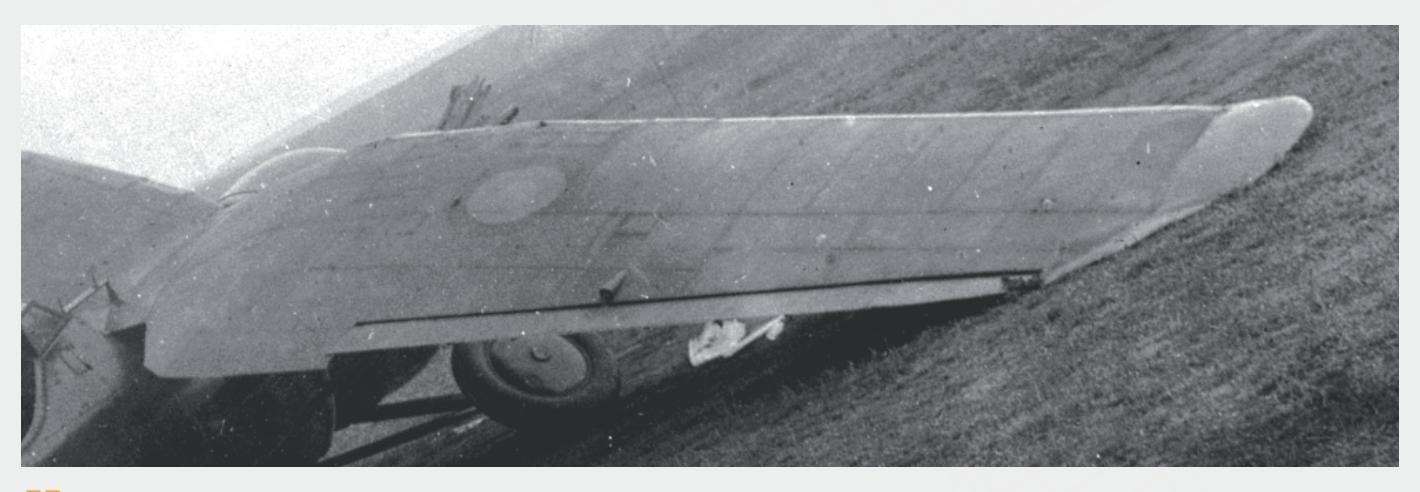
J Starboard wing of P.11F. Note the 'chessboard' of panels, covers visible in the photos above, positioning of aileron actuator and two lifting hooks near the cockade. Again, all aspects (apart from the fairing immediately in front of the windscreen) were identical with P.11c. (Horia Stoica/Dan Antoniu collection)

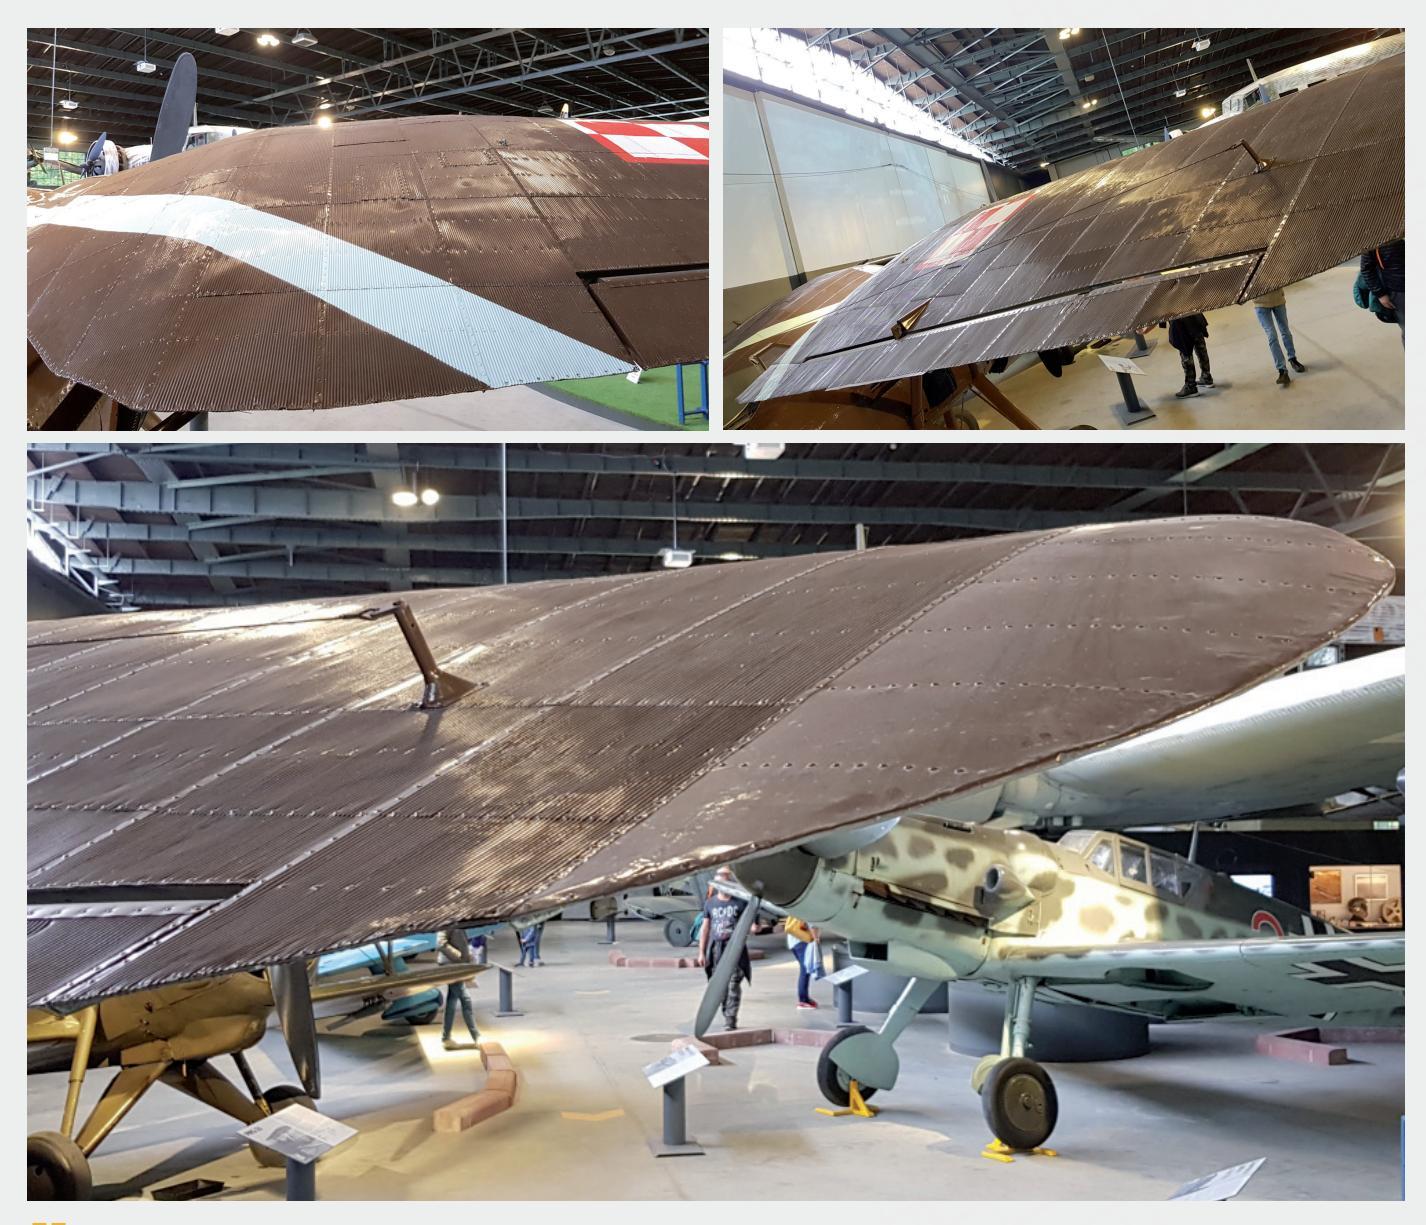
Starboard wing of museum P.11c. Note the surface details and that the wingtip was covered with smooth skin. These photos show well how the light reflects from corrugated surfaces as opposed to smooth ones. Compare the effect with the IBG model wing. (Michał Skawiński)

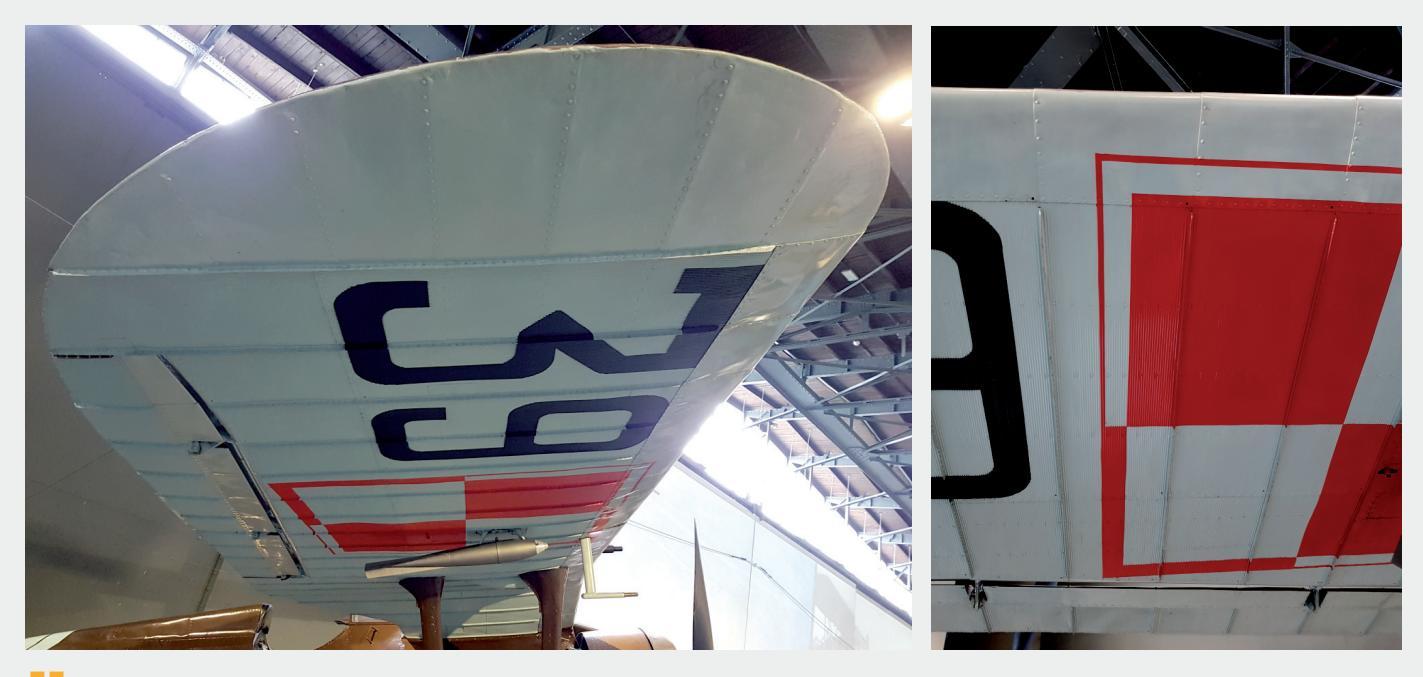
🥖 Skin details on the museum P.11c. Note the combs, smooth vs. corrugated skin division and rivets. (Michał Skawiński)

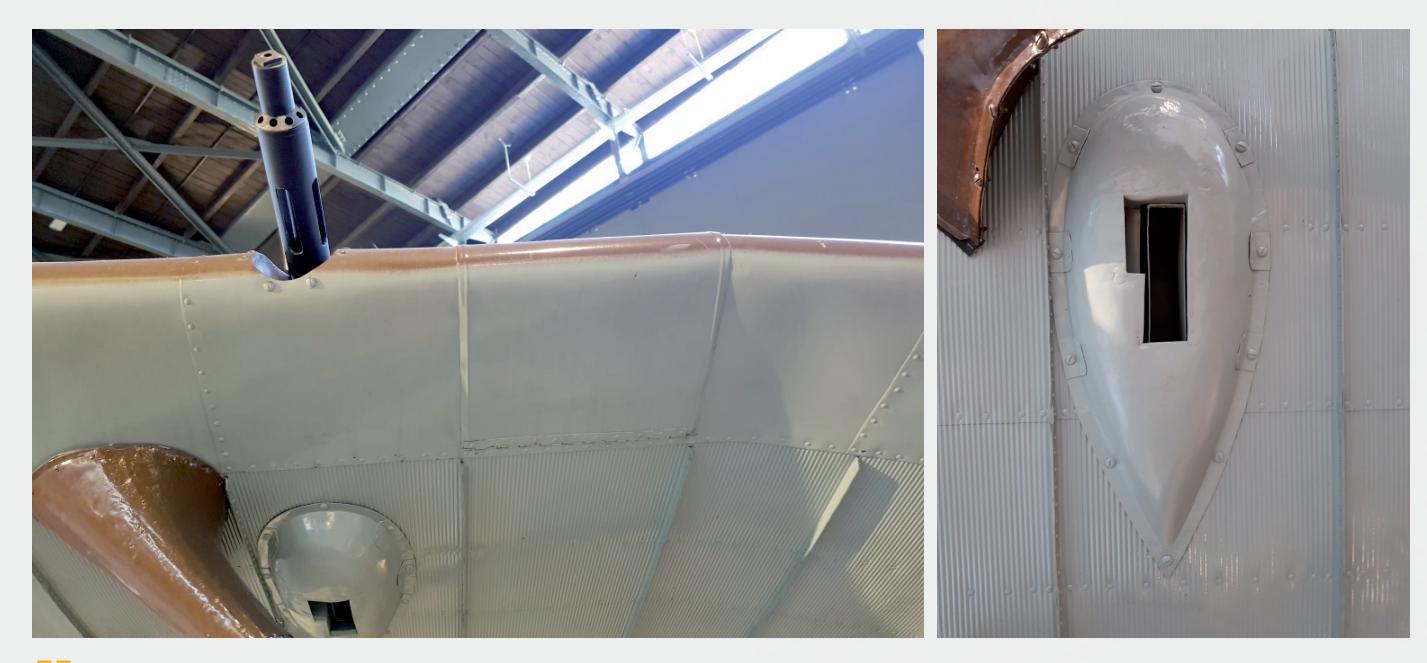
At left – another opening panel in the leading edge of the starboard wing, this time giving access to the inner cover of the machine gun barrel – note the hinges. While in P.11c these were not symmetrical on both wings, in P.11F they actually were. Right photo – spent link and cartridges chute. When wing armament was installed, so were the additional elongated chutes in the form of long pipes - see section on the armament. Small sheets of metal under the screws are most likely not original. (Michał Skawiński)
