P11F REDISCOVERED

Michał Skawiński

History of the Type

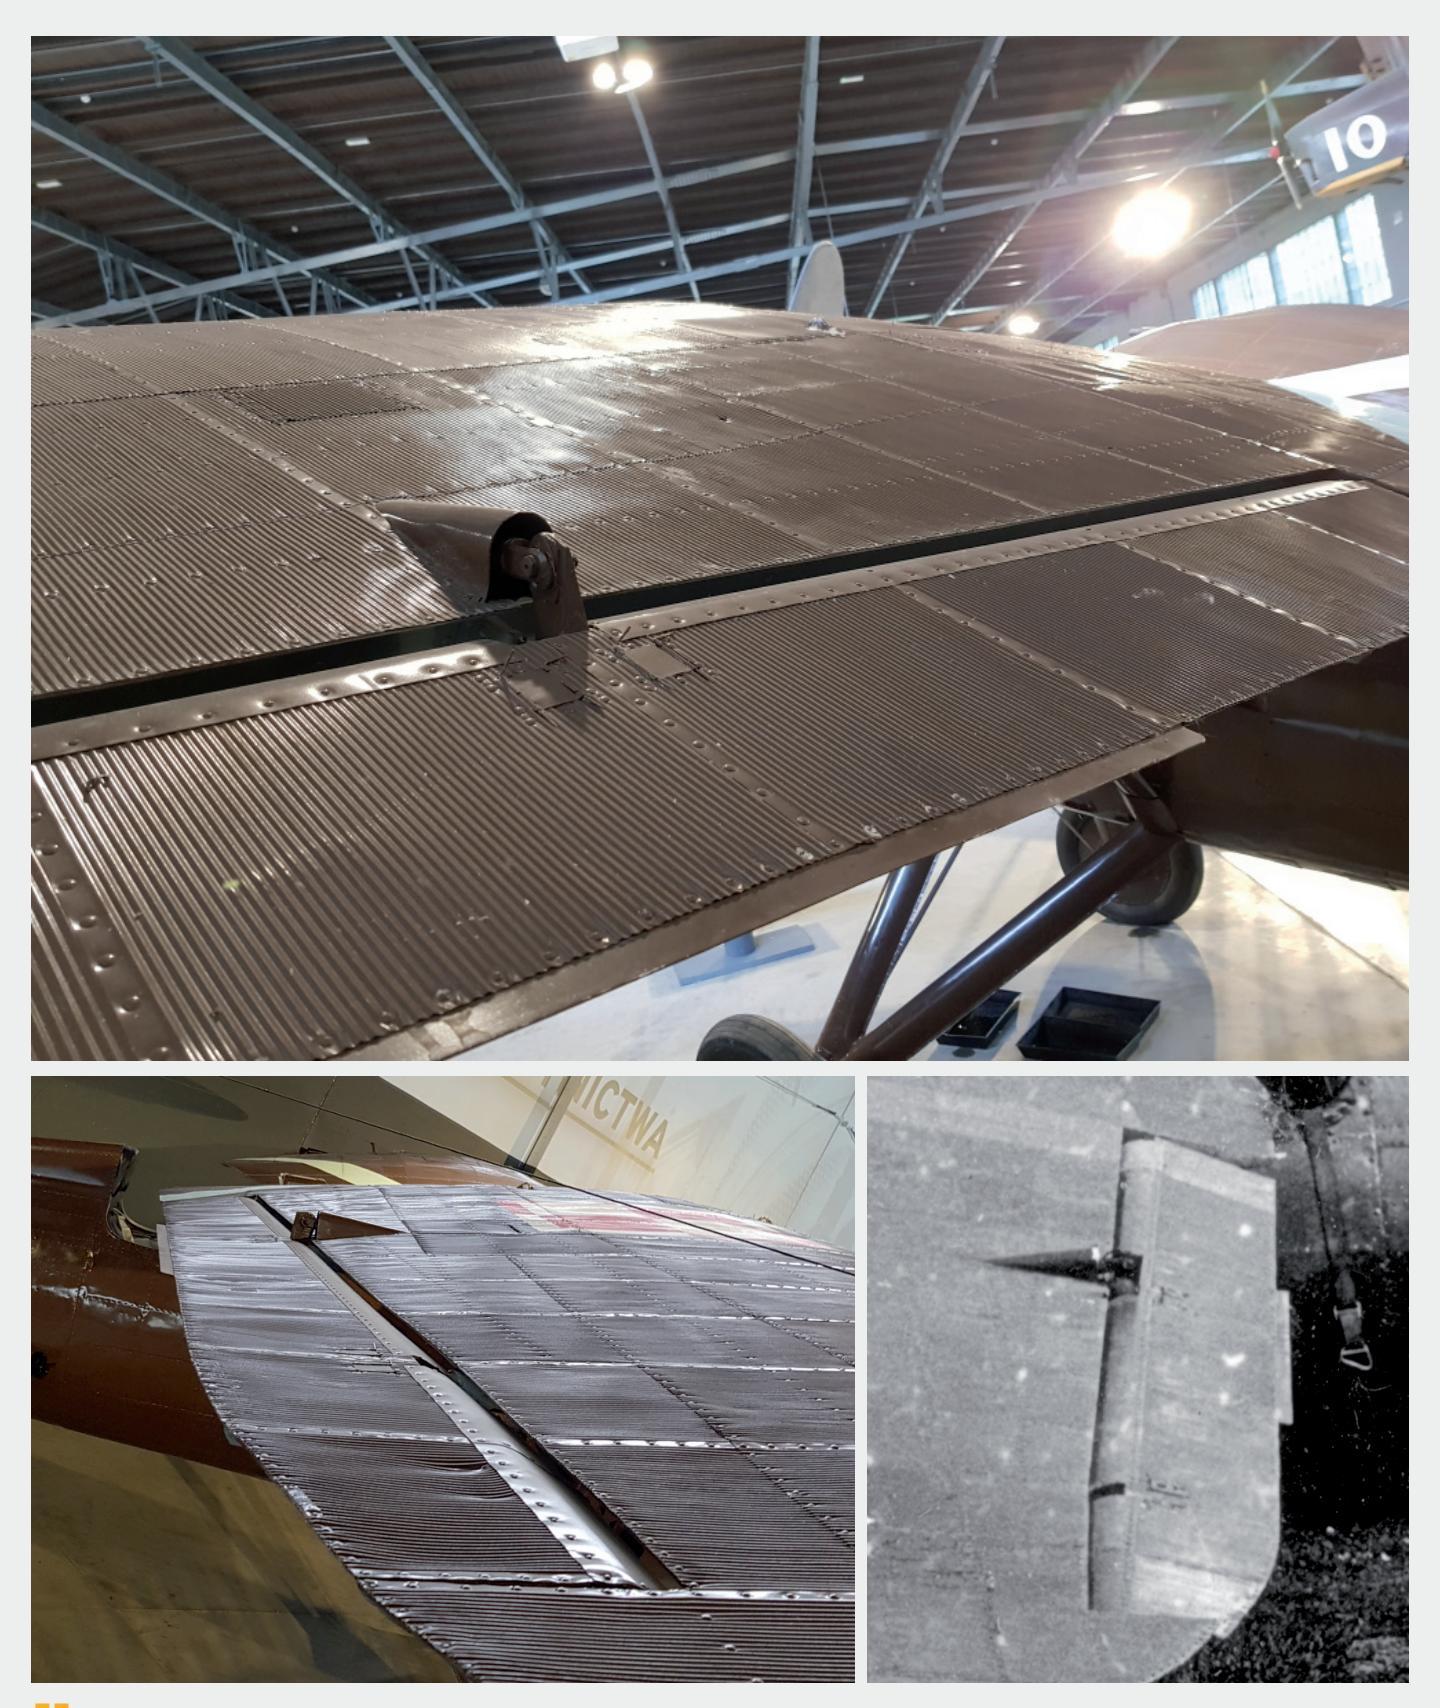
Ailerons were identical on P.11c and P.11F. The hinge area was covered with smooth skin, while the rest with corrugated. Same as for the rest of the wing, combs were only on the undersurfaces. Note the actuators and the trim tabs on both ailerons. (Michał Skawiński, Horia Stoica/Dan Antoniu collection)

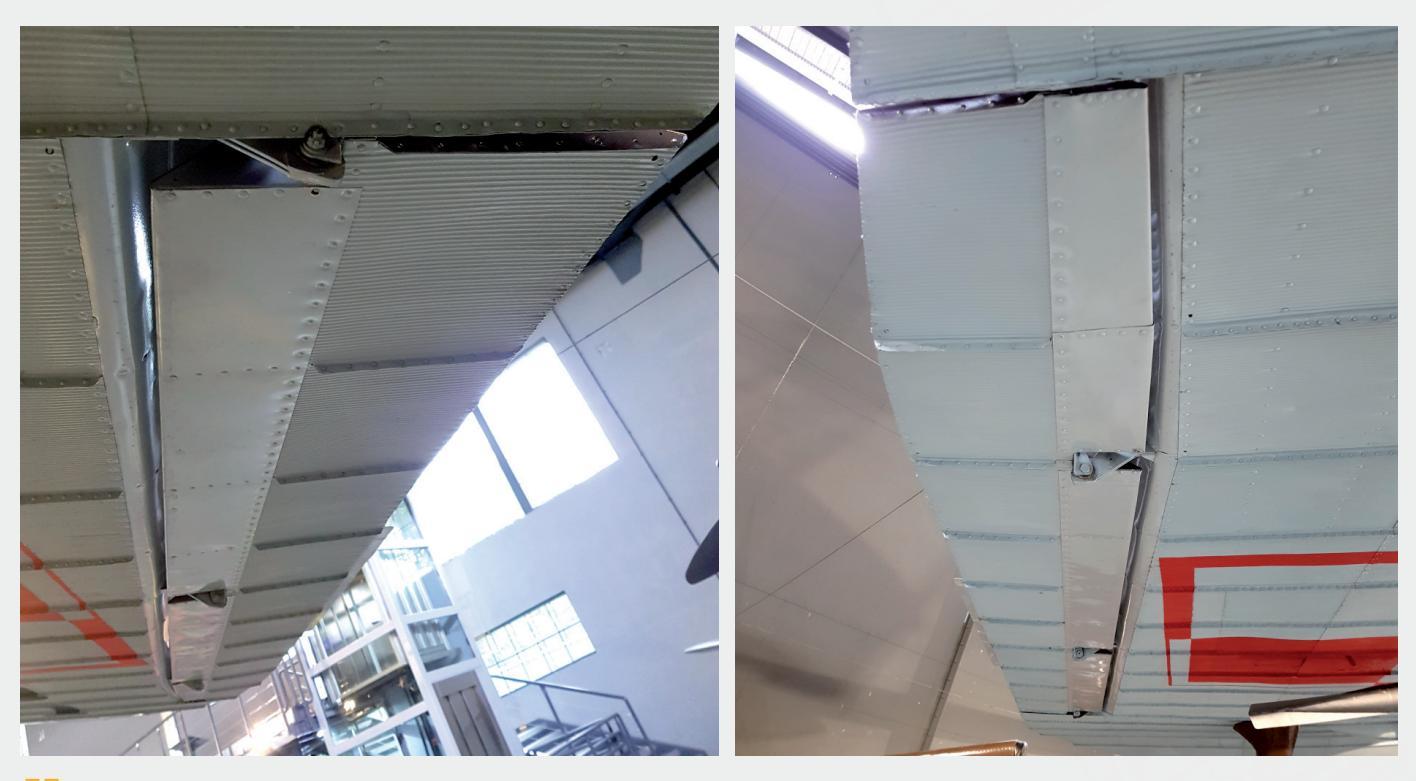
🥖 Two photos showing ailerons on the museum P.11c. Note the areas of smooth skin and the combs (Michał Skawiński)

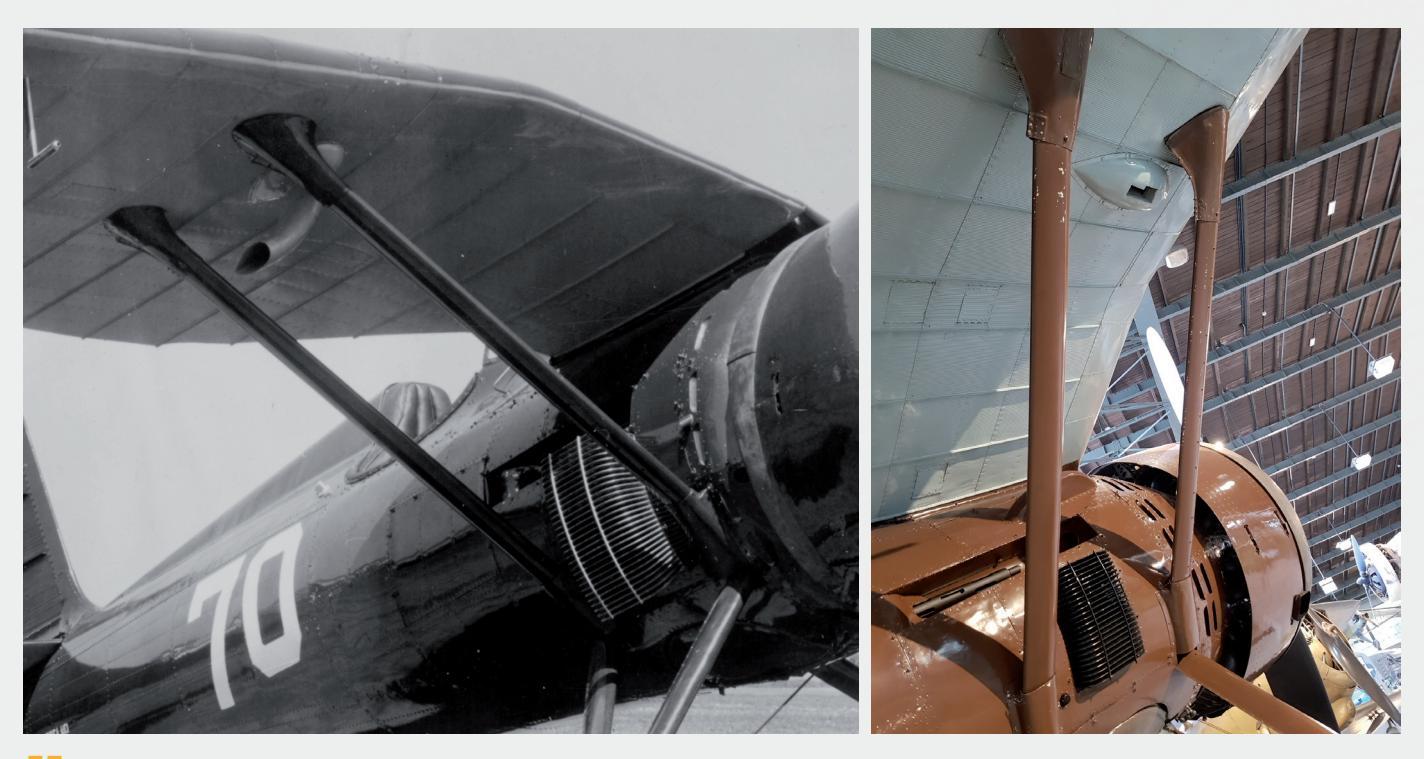
Underwing struts were one of the recognizable features of Puławski's fighters (left – P.11F, right – museum P.11c). Struts had a streamlined cross-section with the front one having the row of hollow rivets running along the centreline. (Tomasz Kopański collection, Michał Skawiński)

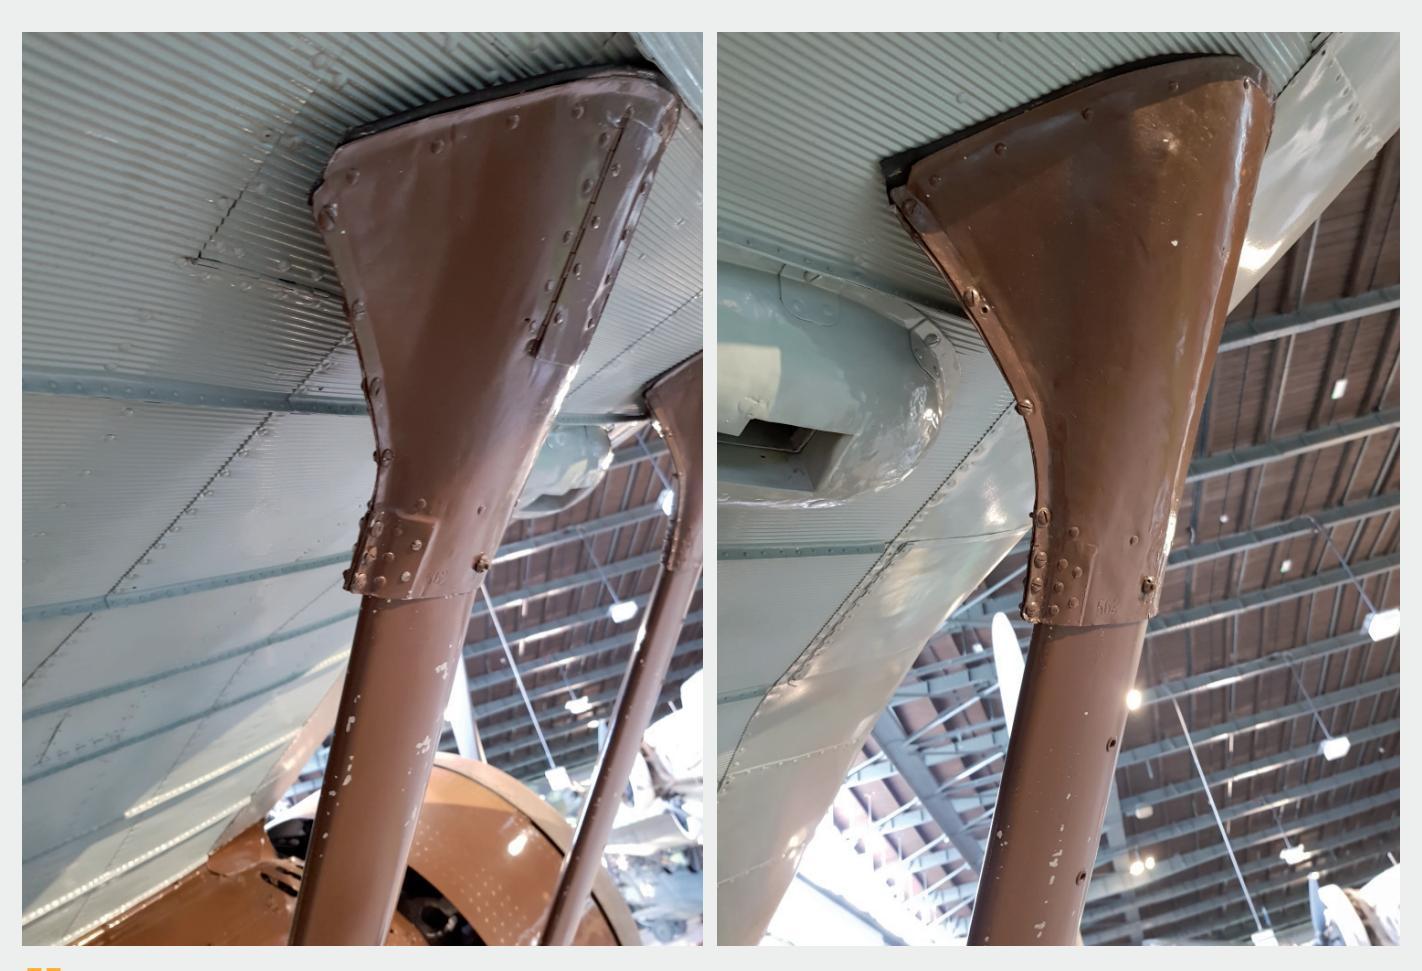
Streamlined covers of the struts. Left – rear one. Right – front one, note the hollow rivets running along the centreline of the strut. (Michał Skawiński)

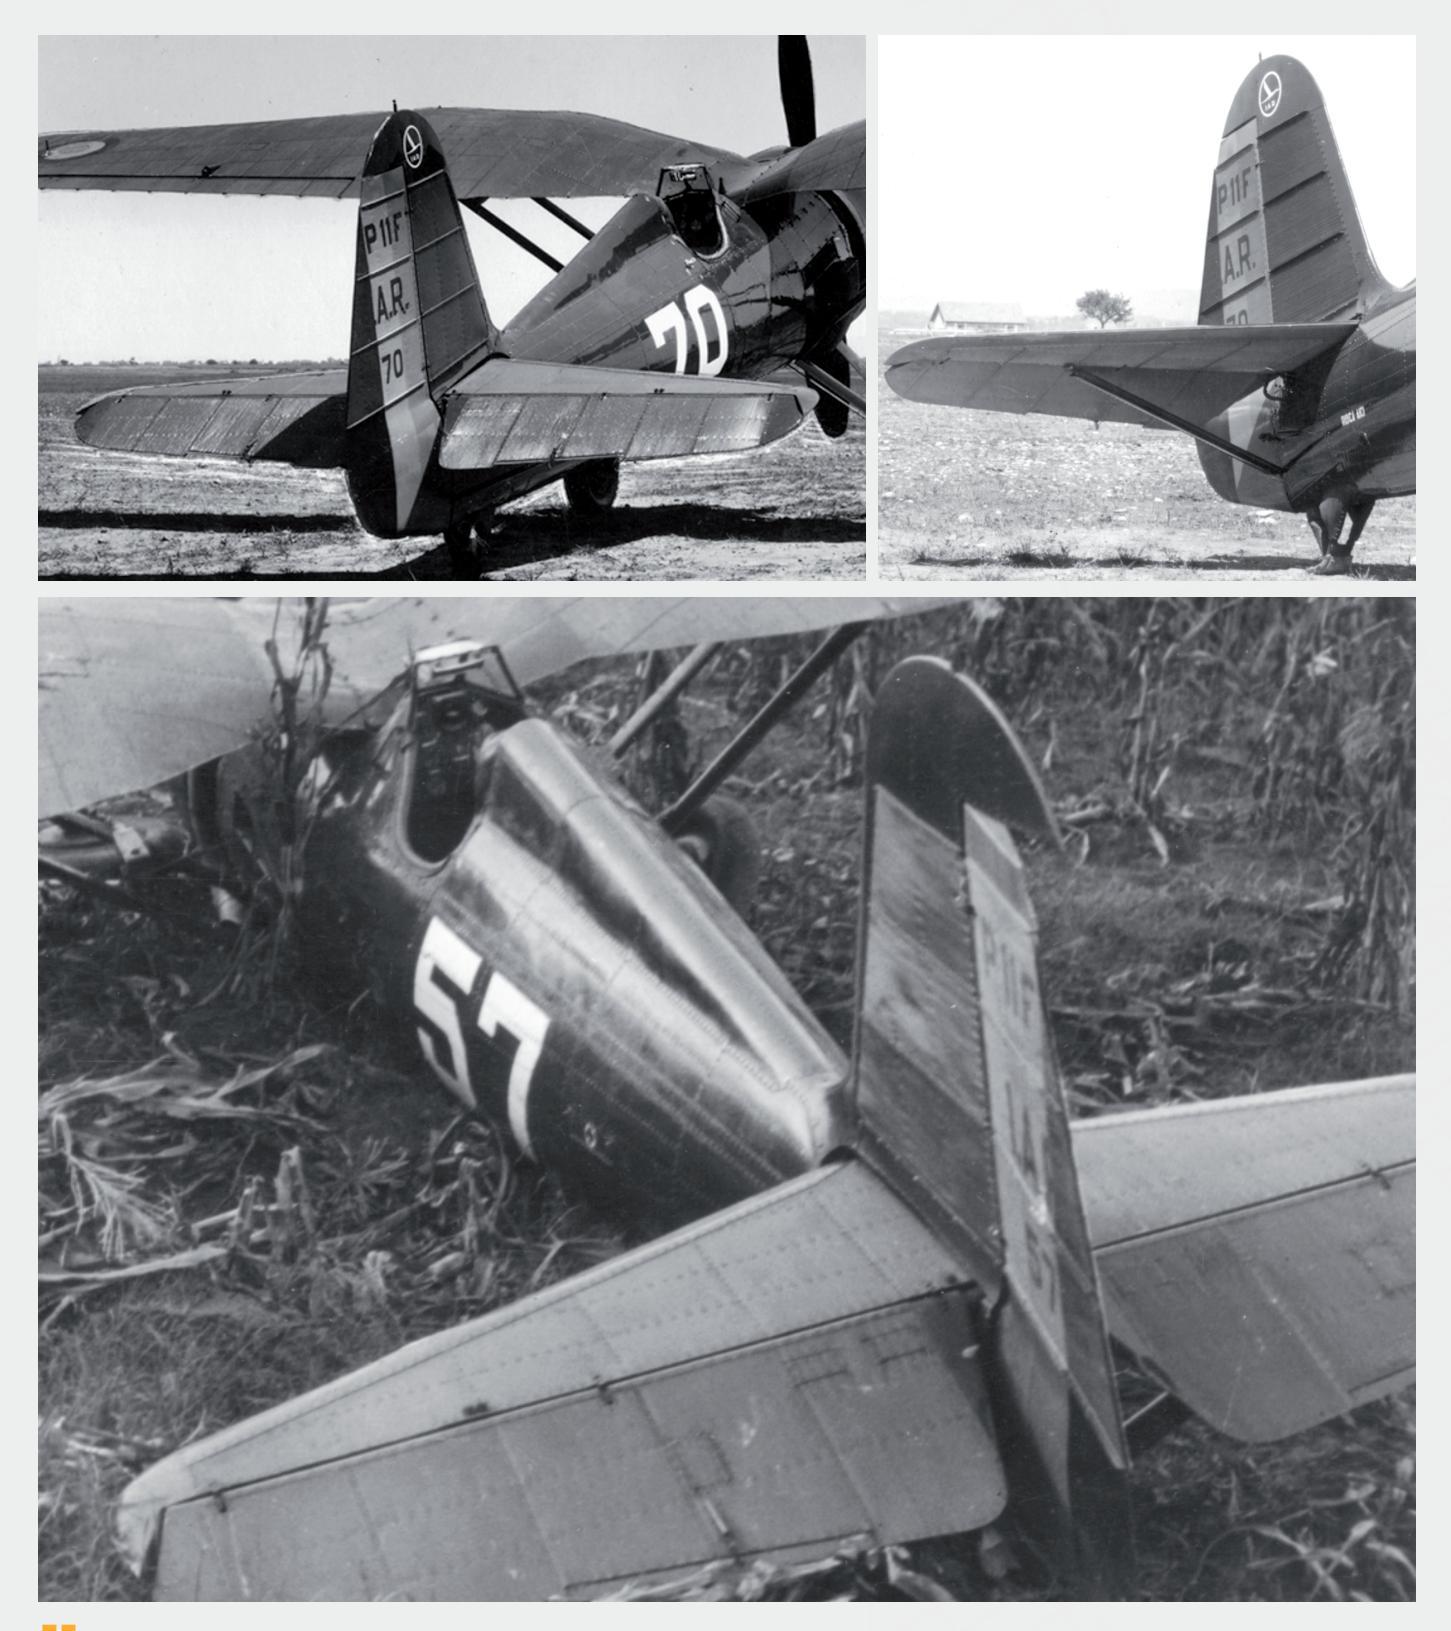
Three photos of P.11F tails. Top – No.70, bottom – No.57. Skin structure of the horizontal tail was similar to that of the wings with corrugated panels of the 28cm width with flat joins on the uppersurfaces and combs at the bottom. Leading edge and the tip were covered with smooth skin. Vertical tail was a bit different, with only three panels of corrugated skin joined using combs on both sides. Leading edge, top and bottom of both the fin and the rudder were all covered with smooth skin. P.11c and P.11F shared identical empennage – probably the most aesthetically pleasing of all PZL fighter tails. (Dénes Bernád, Tomasz Kopański and Horia Stoica/Dan Antoniu collections)

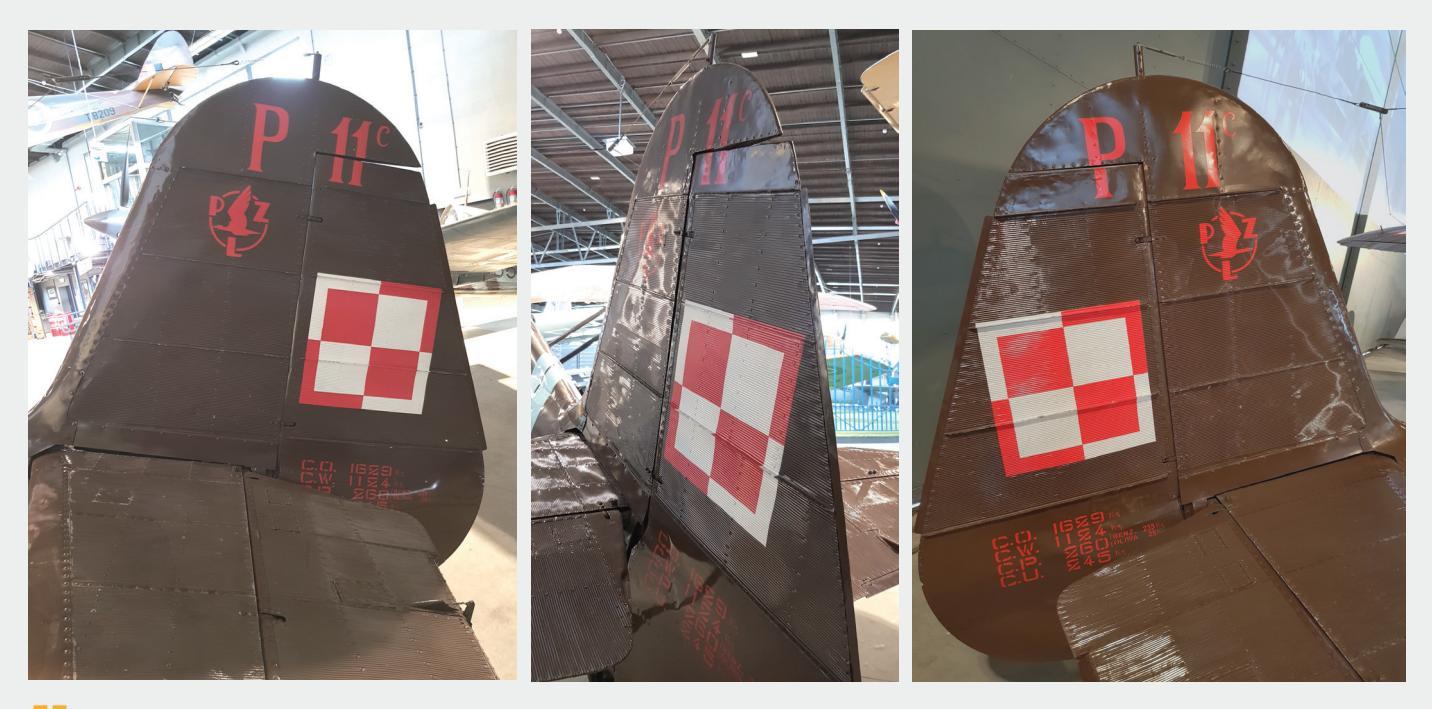
Vertical tail of the museum P.11c. Note the corrugated vs. smooth skin areas, trim tab not adjustable in flight and details of the riveting, including prominent rivets on the leading edge. (Michał Skawiński)

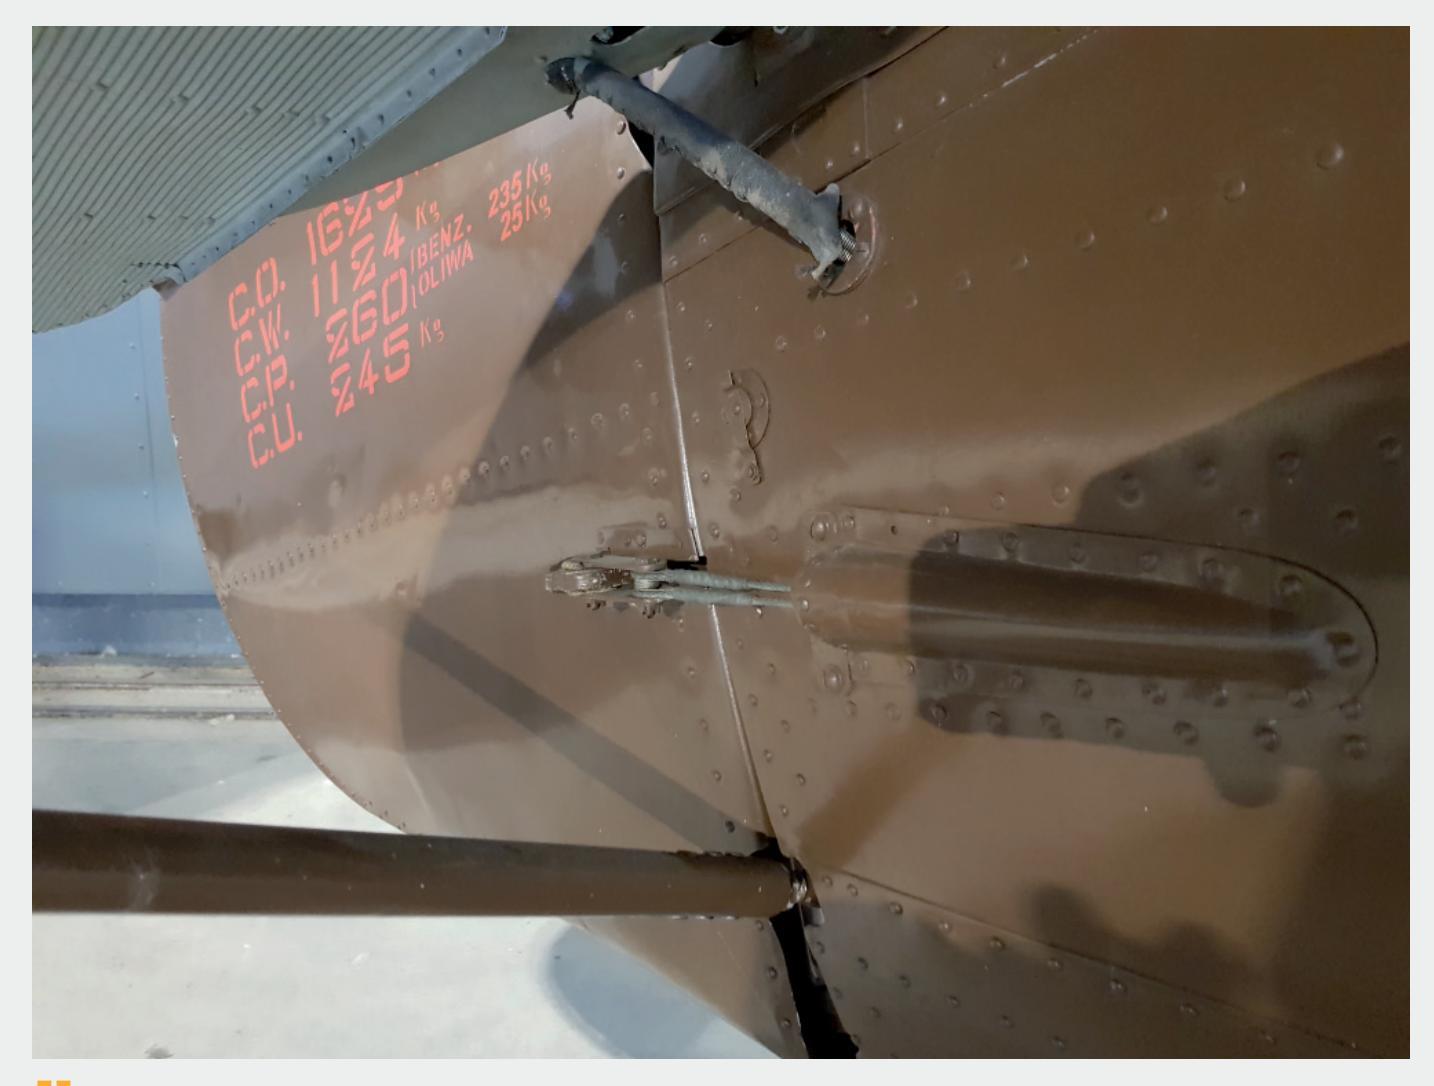
Rear of the fuselage and bottom of the rudder (covered with smooth skin). Note the actuator in the centre, strut mount in the bottom and the Bowden cable for controlling the elevator trim tab at the top. (Michał Skawiński)

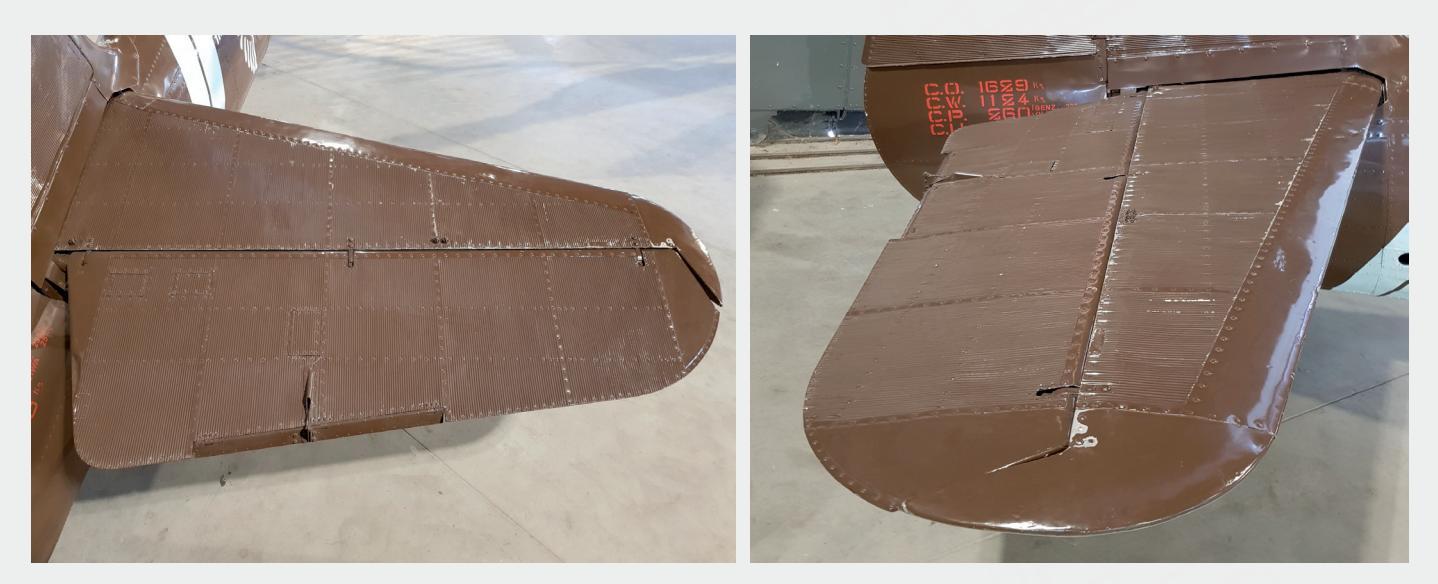
Horizontal tail of the P.11c was identical to the one on the P.11F and was rich in detail. Inspection panels on the elevator facilitated servicing of the trim tab Bowden cable. Note that corrugated skin on the horizontal stabilizer reached all the way to the fin, while on the elevator the inner part was smooth (as was the hinge area and the trim tab). The visual effect of light reflection off the different types of skin is the same as discussed in the wing section. (Michał Skawiński)

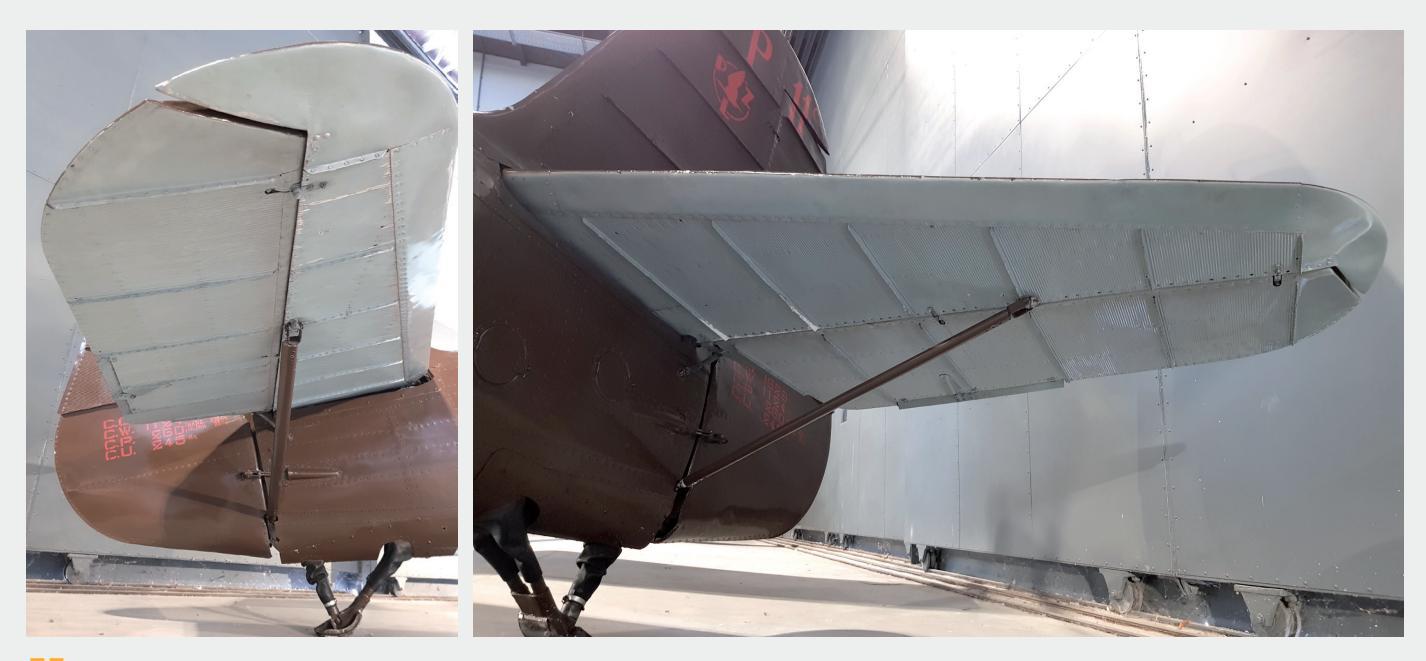
Two more photos of the horizontal stabilizer. Note the smooth skin on the tip, hinge details and the fact that the strut has a more rounded cross-section than in the instructions photo above. The reason for this difference is not certain, but all photos of *P*.11F known to the author show the more streamlined version, as seen in the *P*.11c instructions. (Michał Skawiński)

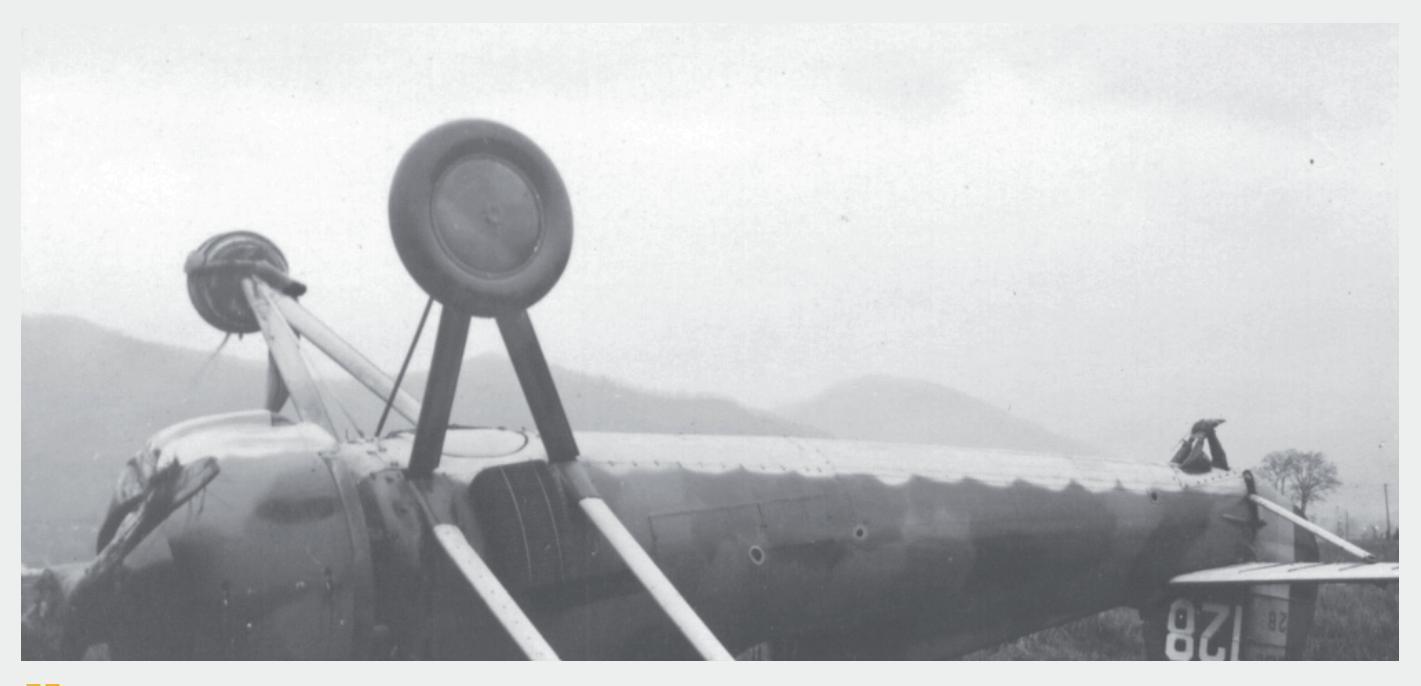
The best position to present legs is lying on the back! This ground-looped P.11F No. 128 shows very well both the V-shaped legs of the main undercarriage and the tail skid. No shock absorbers are visible, as they were hidden in the fuselage as a measure to reduce drag. (Horia Stoica/Dan Antoniu collection)

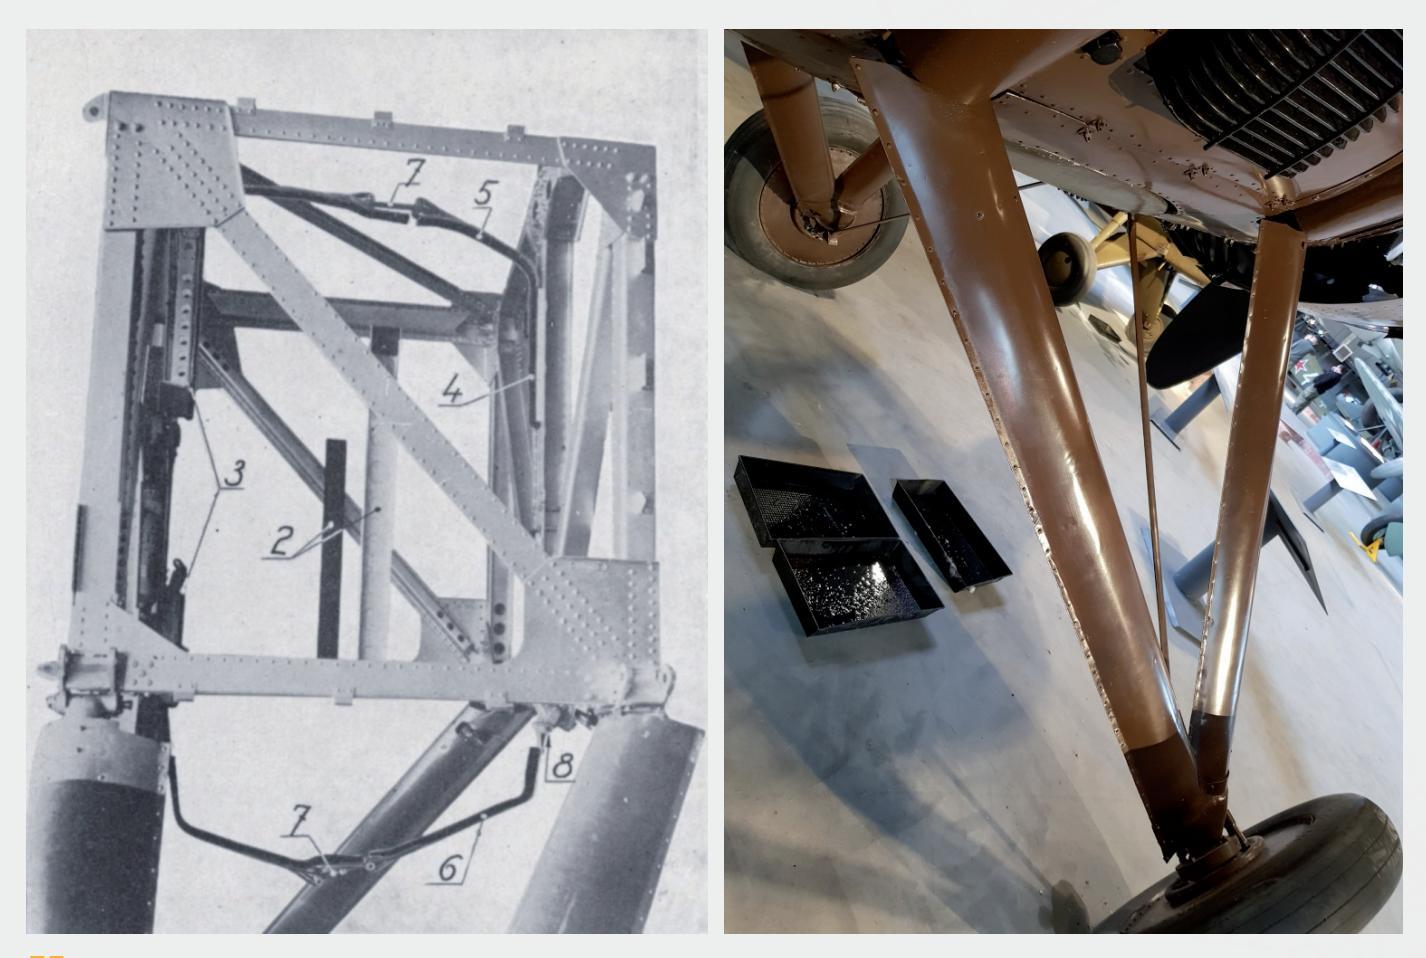
Left – forward truss section of P.11c fuselage to which the main undercarriage (visible at the bottom) was attached. This element was almost certainly identical in P.11F. Right photo – V-shaped legs. Streamlined in cross-section, they had a row of rivets on the trailing edge. (Muzeum Lotnictwa Polskiego, Michał Skawiński)

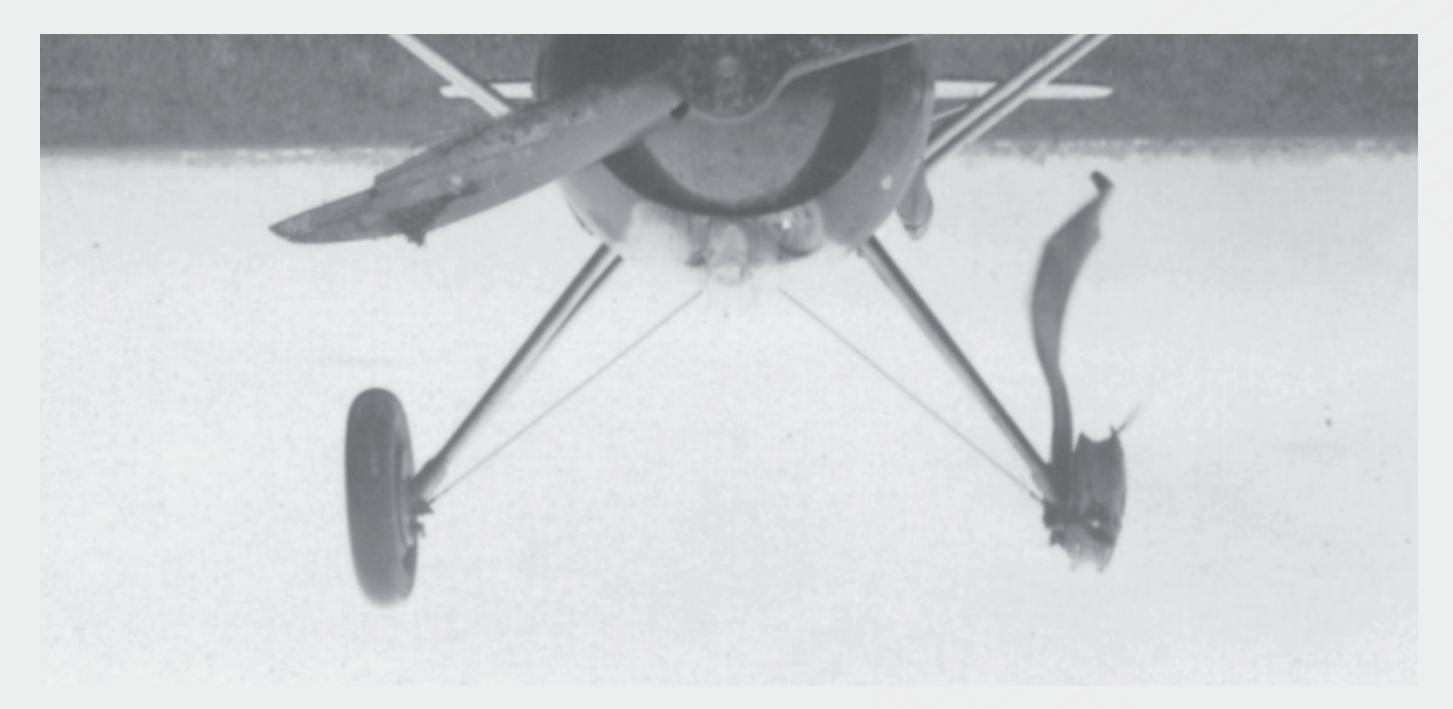
Another photo of a ground-looped P.11F No.128 shows the angle of the undercarriage legs without load (in flight). When on the ground, the track width was slightly larger. (Horia Stoica/Dan Antoniu collection)

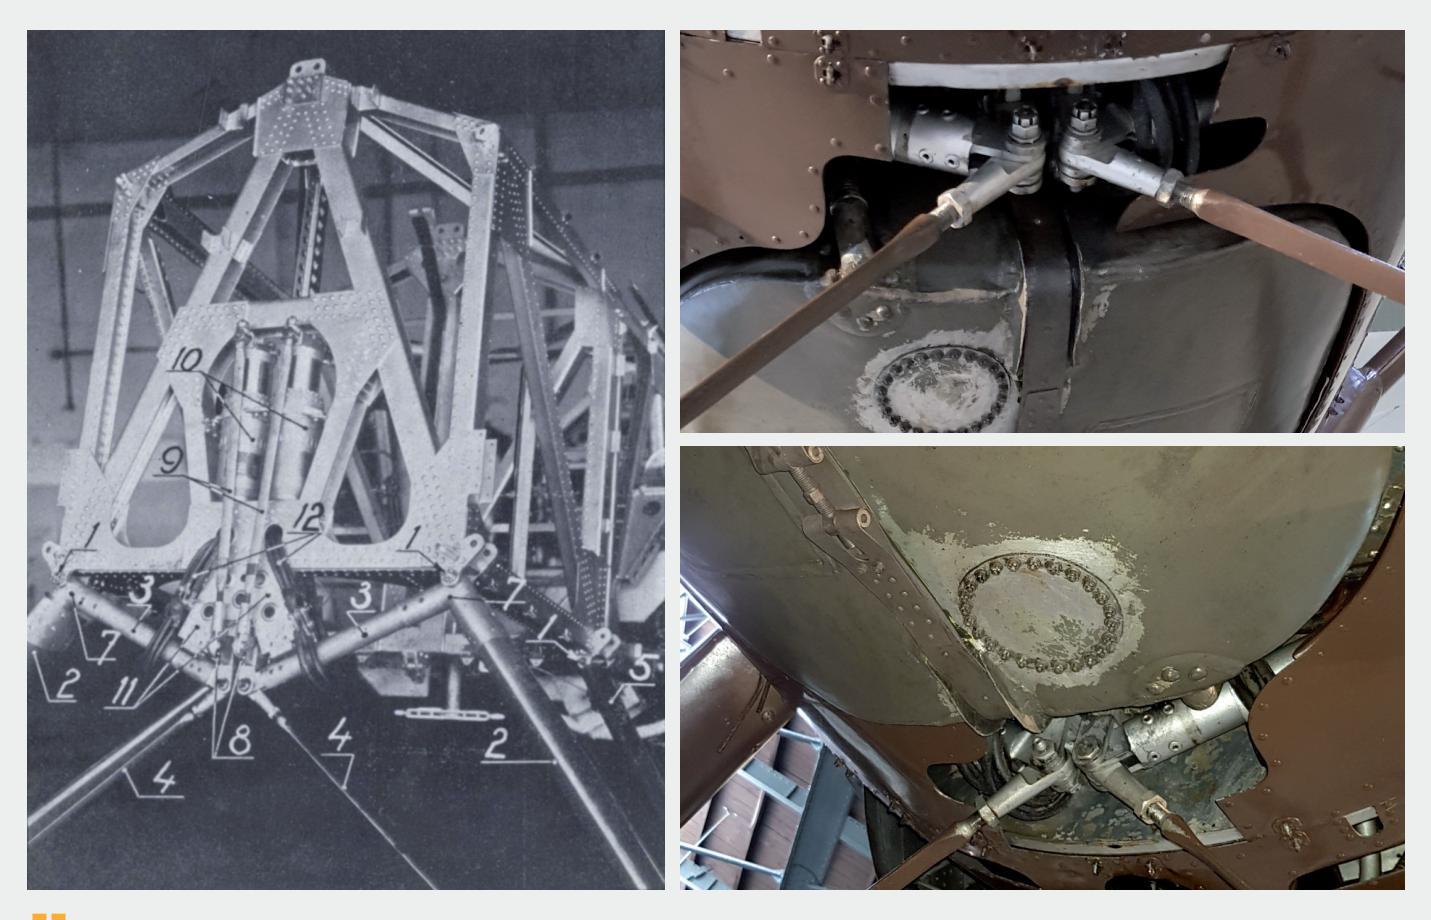
Left – another photo of the front truss section from P.11c instructions. Metal rod (4), flat in cross-section apart from the attachment points, together with the undercarriage leg (2) and a steel diagonal lever leading to the fuselage centreline (3) created a triangle providing structural strength to the undercarriage. The load was transferred from the undercarriage through the steel tendons (9) to the vertically placed shock absorbers (10). Each of them worked independently and so did the undercarriage legs. At right – two photos of the attachment points of metal rods (marked as 4 in the left photo) to the steel diagonal lever (3) as can be seen in the fuselage bottom, immediately in front of the fuel tank. Top photo shows the view from the front, while the bottom one - from the back. Note how the metal rods cross-section changed near the attachment point. (Muzeum Lotnictwa Polskiego, Michał Skawiński)

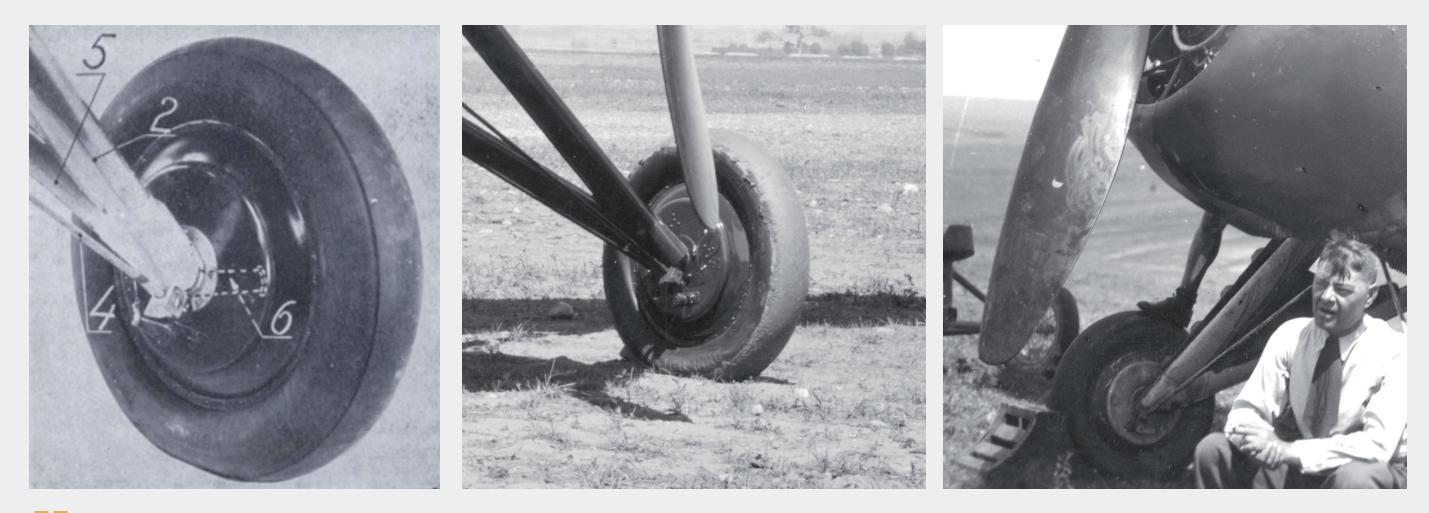
Photo of the wheel from P.11c instructions provides a view on how the undercarriage legs (2) and metal rods (4) were attached to the wheel hub. The same can be seen in the close up of the P.11F No.70 photo (centre). Note the lettering on the Dunlop tyre inner face. Photo at right shows how this area looked in service. Note the accumulated dirt and oil stains, especially on the undercarriage legs. Wheel chocks are also well visible. (Muzeum Lotnictwa Polskiego, Tomasz Kopański, Horia Stoica/Dan Antoniu collections)

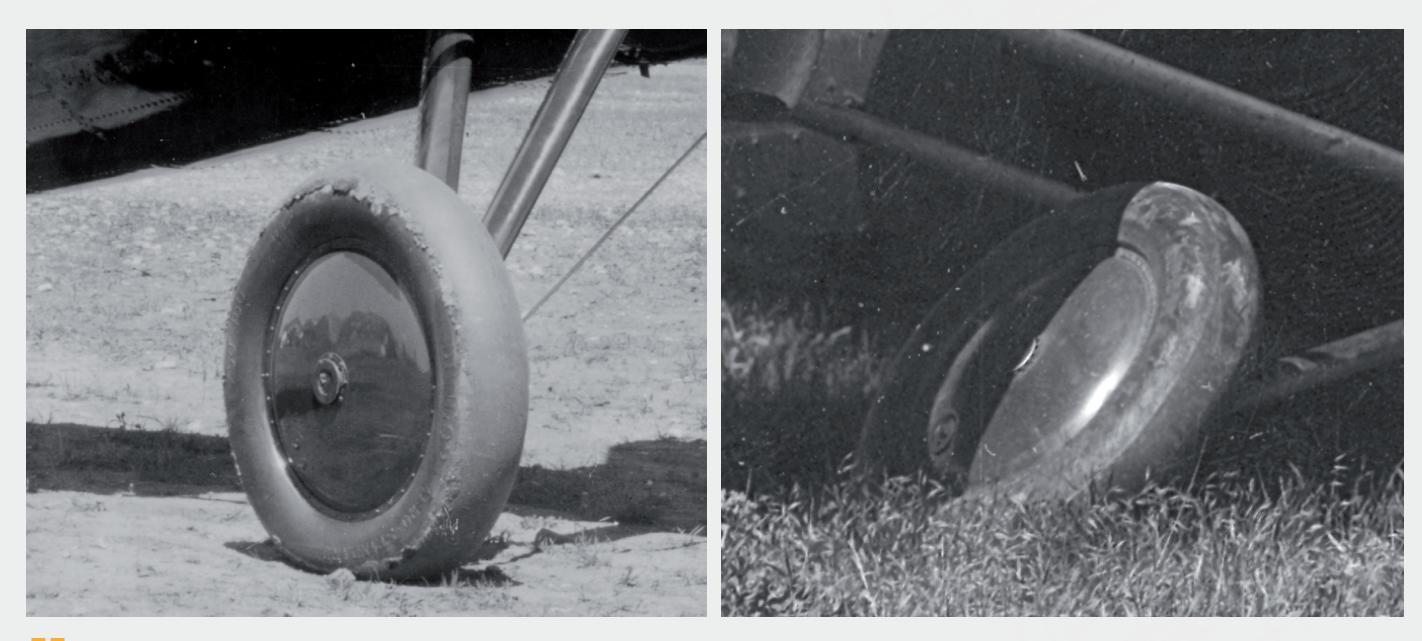
Details of the wheel hub. Even more interesting are the tyres. At left, there is a photo of the factory-fresh airplane No.70. Writing on the tyre says: DUNLOP AERO - STANDARD 750 x 150. Already in 1937 Romania started importing tyres of the Polish company Stomil that were also used on P.11F. A wheel with this tyre is visible at right (photo is dated 1941). Note the fragments of the POLSKA OPONA LOTNICZA STOMIL 750 x 150 that can just be made out on the tyre. (Tomasz Kopański, Horia Stoica/Dan Antoniu collections)

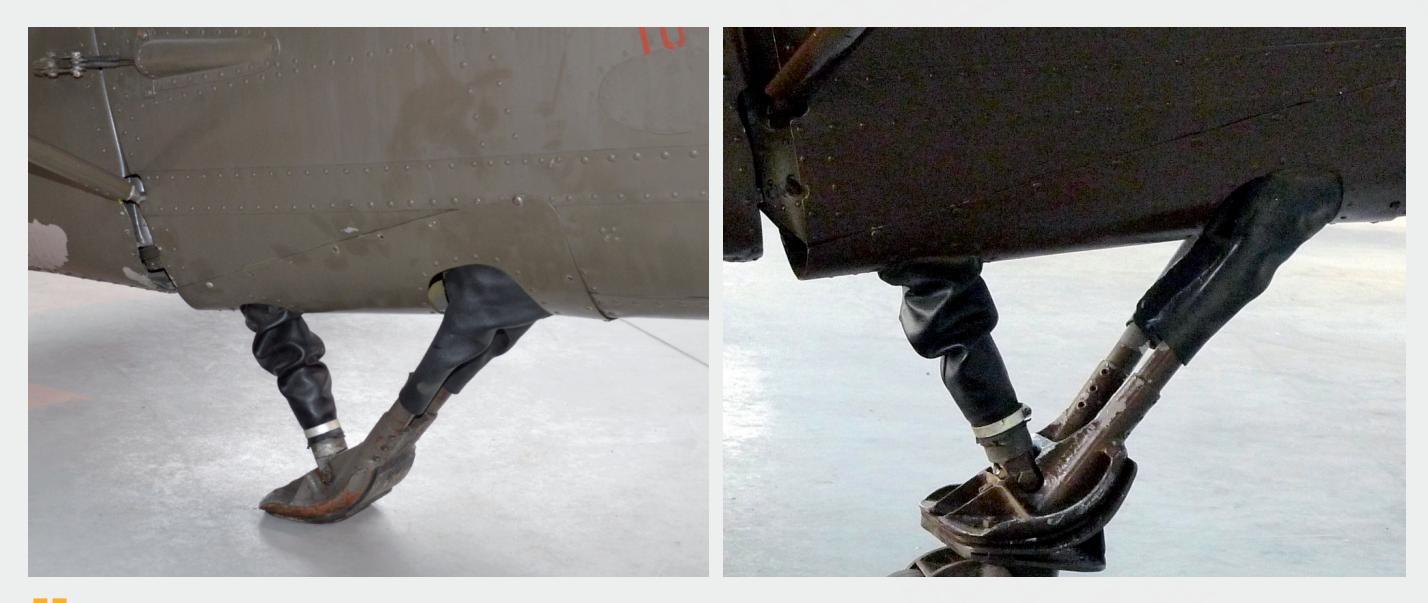
Two photos of museum P.11c confirming the details shown in the instructions. Note that in the photo at right the tailskid is mounted on the additional single-wheel trolley. (Marek Możdżeń, Michał Skawiński)

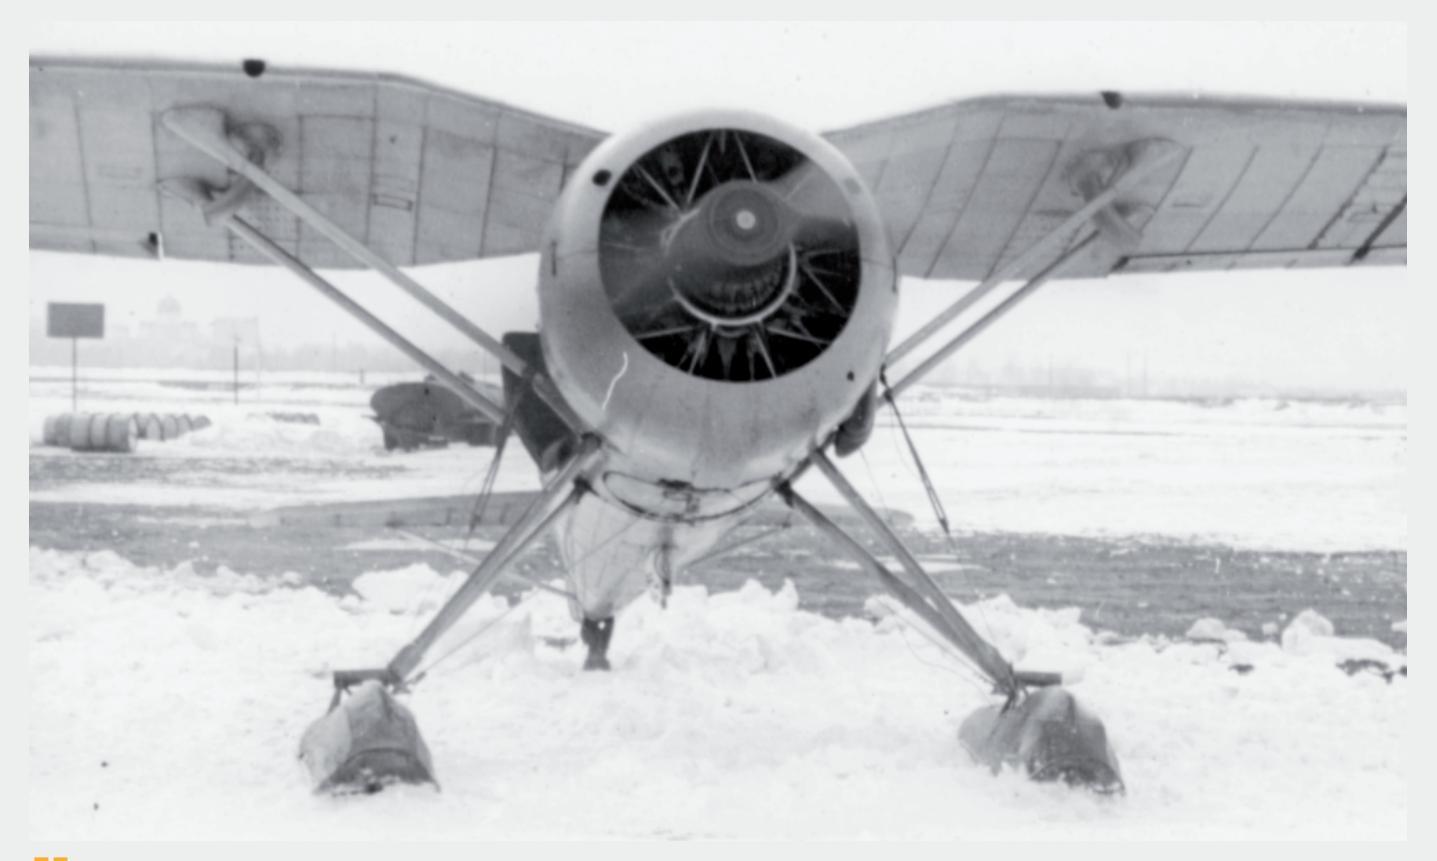
In the winter, wheels could be changed to skis. Romanian P.11F used locally-produced SET skis, but this is yet another story. (Horia Stoica/Dan Antoniu collection)
